## CORROSION OF RESEARCH REACTOR AL-CLAD SPENT FUEL IN WATER

### SUMMARY

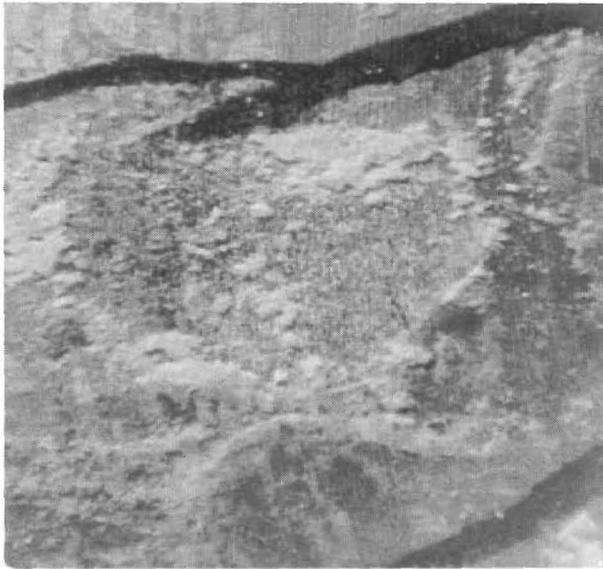
Some pitting was noted even in the high purity water of the RA6 reactor pool. This pitting was always associated with deposited particles. Pits, 1-2 mm in diameter were produced in waters with no detectable amounts of chloride or sulphate and with conductivity less than 2  $\mu\text{S}/\text{cm}$ . The particles were thought to be iron oxide and were cathodic to the aluminium. Conditions inside some of the crevices resulted in oxide patches. Other areas seemed pickled, possibly by acidification of the water within the crevices. Small pits (0.1 mm in diameter) were found inside these crevices. Results of these investigations showed that the basin storage environment contained floating particles and it was not always possible to associate the degree of pitting with water composition.

Fig. 7: Coupon 6064/64; crevice corrosion (18X)

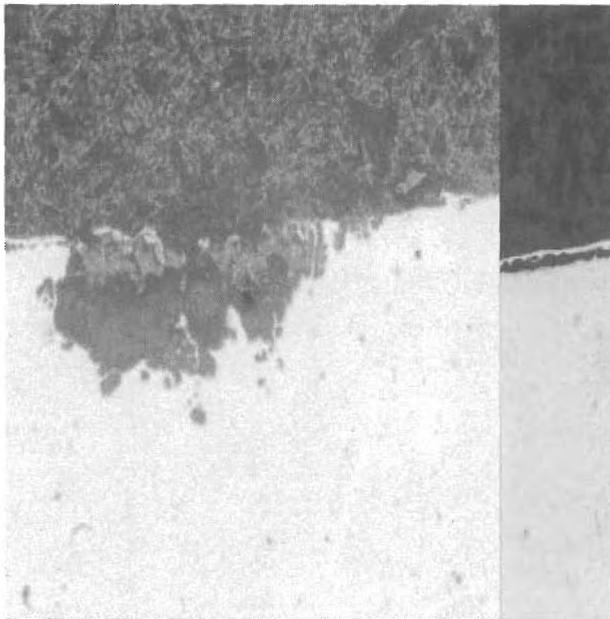
Fig. 8 Cross-section of an isolated pit 50X

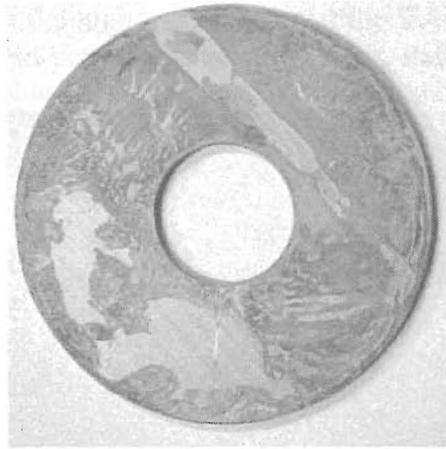
Fig. 9: Uneven oxidation (x 1)

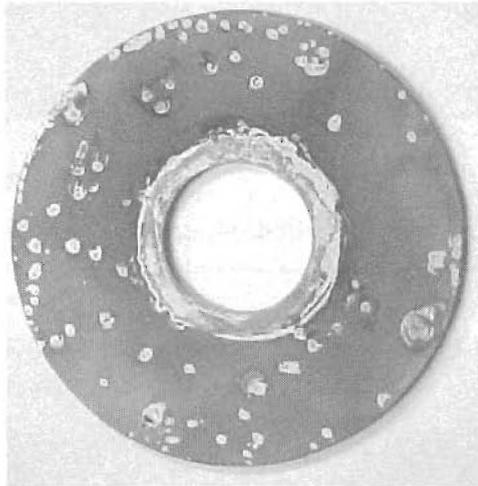
Fig. 10: Pitted surface (x 1)

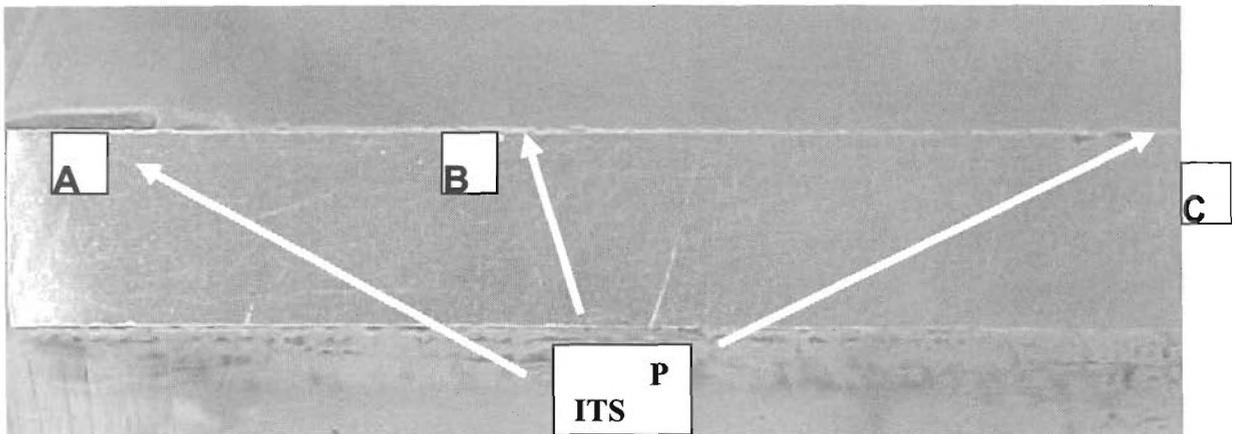
Fig. 11: Cross section of coupon revealing pits A, B and C. Coupon thickness: 3 mm

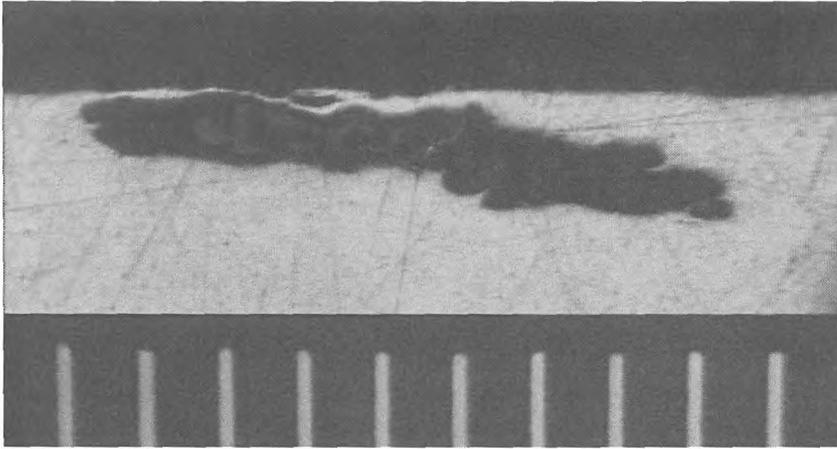
Fig. 12: Pit A from Fig.11 at higher magnification. One division equals 100  $\mu\text{m}$

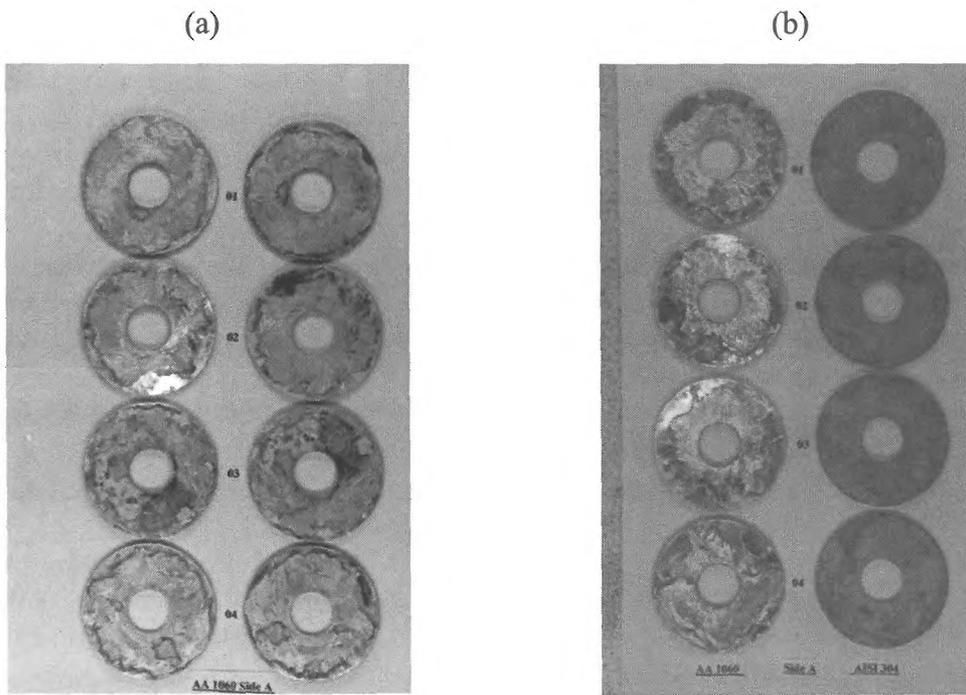
Fig. 13. Surface features on the facing surfaces of AA 1060/1060 crevice couple coupons and AA 1060/ AISI 304 galvanic couple coupons

The first inspection of the IAEA racks was conducted after about 6 months. All three galvanic and crevice coupons were stuck together, requiring forcible separation. The aluminium coupons were coated with a white/grey deposit typical of aluminium oxide. The pH was measured inside the crevice and it ranged between 4.0-4.5 (acidic). The glass ampoules had a brownish tint, indicative of radiation damage. After these observations, the coupons were re-assembled and returned to the basin for continued exposure. After an additional year of immersion, the rack was taken out of the water at a demonstration during the Sao Paulo RCM. It was disassembled and examined visually. The white oxide was observed in the crevice. In addition, small metallic particles were imbedded on the surface of some of the aluminium coupons. The particles were believed to be cathodic, possibly iron, as a halo existed around the particle/pit. This halo was bright and appeared to be free of corrosion. IAEA Batch-II racks 2 and 3 were immersed in the basin in August 1998 and were removed in October 1999. Examination of the coupons, revealed a few small pits within the crevices of the galvanic coupons and more pits at the contact points with the ceramic separators. Some loose deposits were seen on the top surfaces of the coupons. The top surfaces of the AA 1100/1100 couples had similar deposits and more than 50 pits < 1 mm in diameter. The bottom surfaces were free of pits.

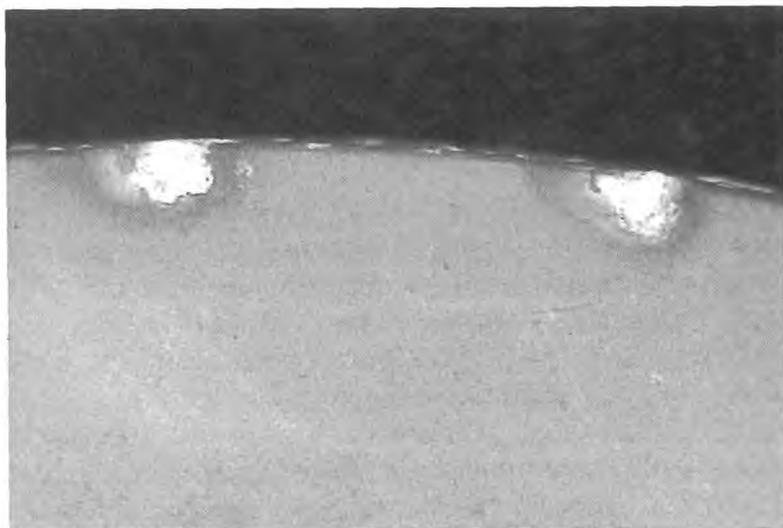
Five racks were immersed in the spent fuel storage pool, and included the rack given by the IAEA in 1996. The basin water was not constantly circulated and it was purified once a year using an ion exchange system. The conductivity of the basin water ranged from 3-10  $\mu\text{S}/\text{cm}$  and the chloride ion content <0.1 ppm. A dark grey oxide layer, from general oxidation, developed on most of the outer surfaces of the coupons in contact with the water. The colour darkened and the layer thickened with time. Crevice corrosion products formed in the crevices between coupons. No pitting was observed on coupon surfaces, but some pitting occurred on the outer rim of the coupons, due to edge effect.(Fig.14)

Fig. 14. Coupon of Rack-2 showing pits
