Microstructural analysis in asymmetric and un-balanced composite cylinders damaged by internal pressure

Abstract

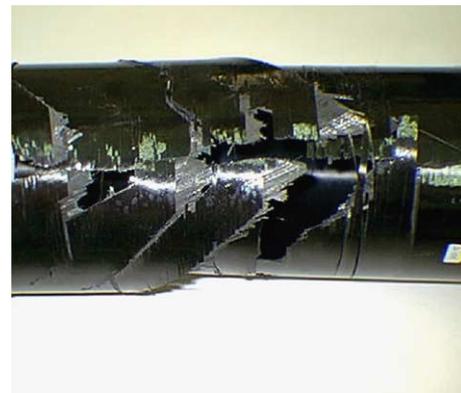
An examination of the collapsed cylinders show different failure modes, as shown in Fig. 1. Macroscopically, there is evidence of a long longitudinal crack, having a translaminar fracture in mode I. This failure is characteristic of structures that are loaded only in tensile stress in the hoop direction under hydrostatic

Fig. 1. Macroscopic aspect of the cylinder C1 after the collapse.

pressure. The failure opened the cylinder in the longitudinal axis from one end to the other.

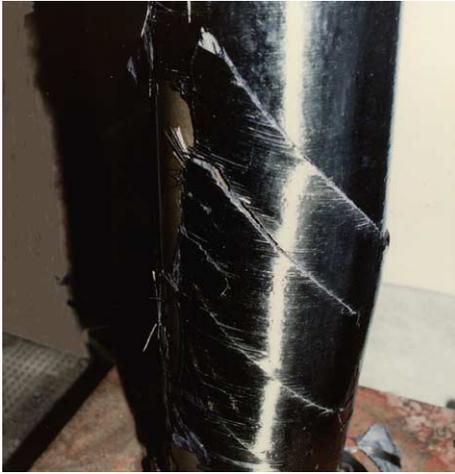
Fig. 2. Helical cracks in the cylinder C3.

In spite of pure uniaxial hoop loading, evidence of shear tension was observed in planes of maximum shear stress, causing helical cracks at 45° in relation to the cylinders axis, as shown in Fig. 2. This phenomenon may have increased by the stacking sequence used to build the cylinders, which resulted in asymmetrical geometry, that caused undesirable bending and torsional effects. These effects can be anticipated by a mathematical analysis presented by Jones [15], due to the presence of the coupling matrix (named as matrix $[B]$), that appears as a consequence of the asymmetry. The presence of the matrix $[B]$ in the mathematical analysis, shows that the loading could not have only produced extensional and shear deformations but also bending and torsion deformations in the structure.

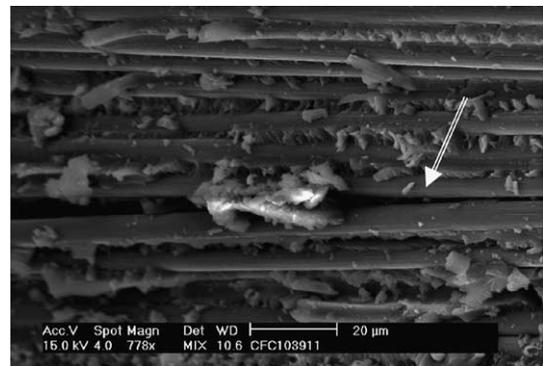
Fig. 3. Debonding effect in the helical layer of 25° of the cylinder C2.

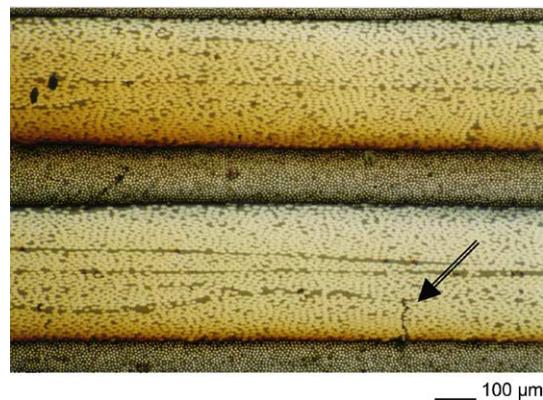
Fig. 4. Transverse crack in the matrix of the cylinder C4 (first helical layer).

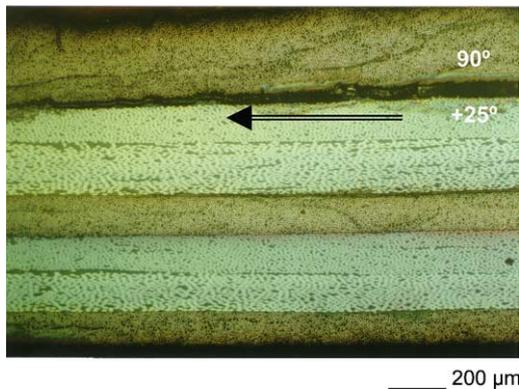
Fig. 6. Delamination between the helical layer of 25° and the hoop layer, in a sample of the cylinder C4.

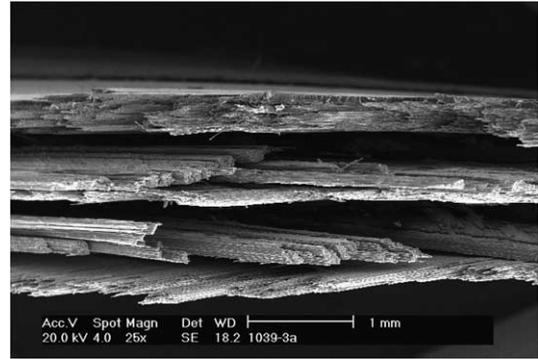
Fig. 7. Photomicrographs showing the transverse section of the cylinder C5, outstanding the delamination among the layers.

Fibres fracture in the direction of the main tension is the worst damage that can happen to polymeric composites that use continuous filaments, as they are effectively responsible for the structural strength of the composite. Fig. 7 shows the layers, in the ascending order, totally separated in a clear indication of shear interlaminar failure of mode II.

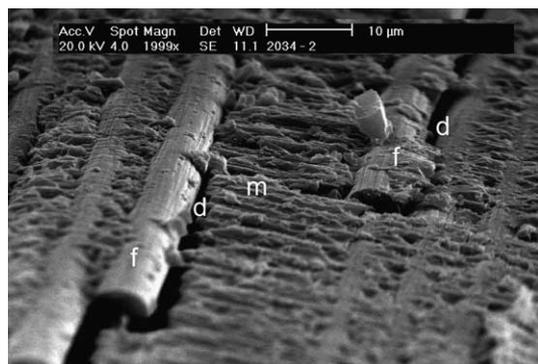
One example of fractured filaments in hoop direction is shown in Fig. 8. This figure shows the intermediate layer of 90° of a sample of cylinder C1. The breakage of filaments (*f*) caused some cracks in the matrix (*m*), producing localized debonding (*d*). If these cracks had continued along the filament they would have resulted in an increased debonding effect at fibre/matrix interface, eliminating the capacity of these filaments to withstand the loading. In this region, eventually due to the increased loading, a stress concentration could occur, causing the failure of filaments that are in the nearest neighborhood, which eventually would result in the failure of the layer. A model proposed by Bader [17] to explain failure behavior of uniaxial fibre composites is shown in Fig. 9.

Fig. 8. Fractured fibre in the hoop layer of cylinder C2.

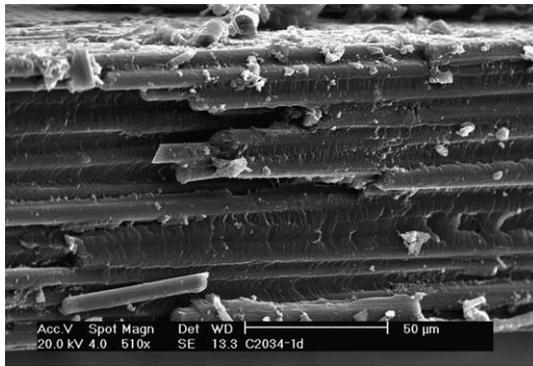
Fig. 10. Failure due to transverse stress in the cylinder C3.

transverse tensile stress. Composites that have a good bonding interface show a feature, named by Purslow, in his work with plates, wavy radial patterns [6]. Fig. 10 exhibits an example of an intralaminar failure caused by transverse tensile stress in cylinder C5.
