# Visual Inspection and Sipping of the IEA-R1 Irradiated MTR Fuel Assemblies

IPEN/CNEN-SP  
Comissão Nacional de Energia Nuclear  
São Paulo - BRAZIL

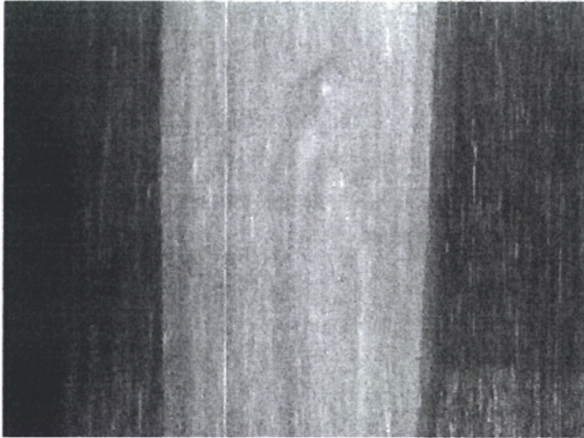
Figure 4 - Loss of Corrosion Layer over the lateral fuel plate: IEA 153; June-2000

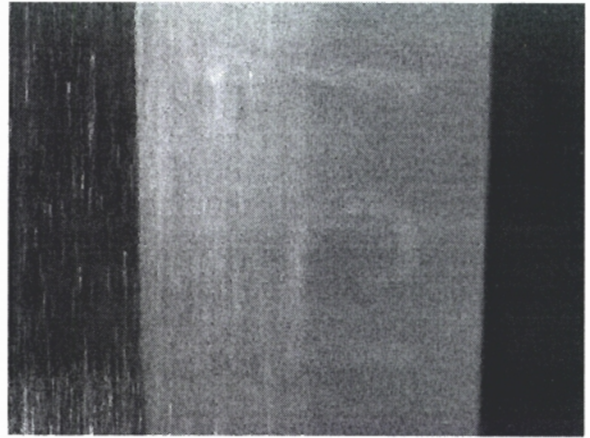
Figure 5 - Pits corrosion on the lateral support surface at the FA Id number region (low relief). IEA 157, Jun/2001

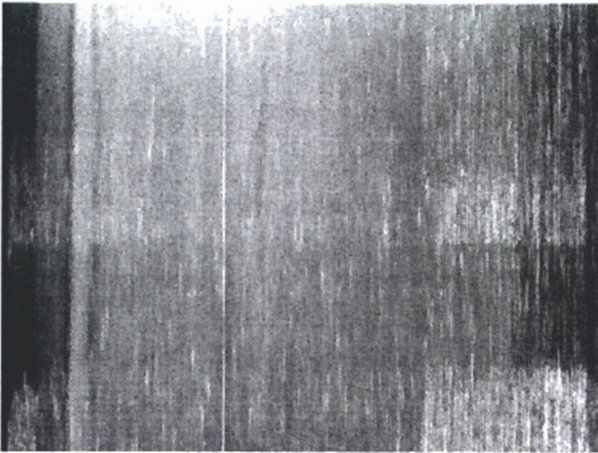
Figure 6 - Risk due handling over the external fuel plate surface (IEA 150, Jun/2001)

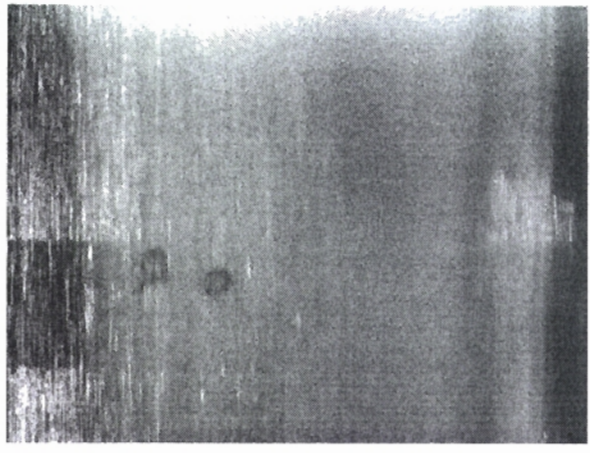
Figure 7- Loss of Corrosion Layer over the external fuel plate; IEA 153; June-200

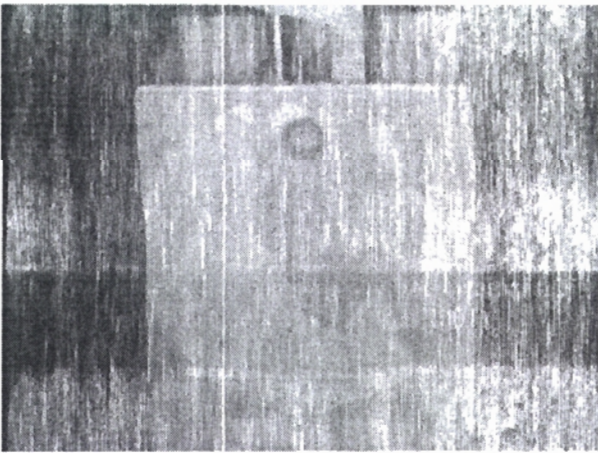
Figure 8 - Corrosion stain at the fuel element support (IEA 163, Oct/1999).

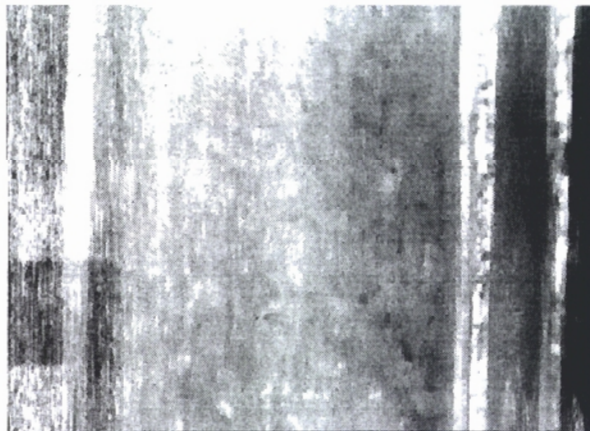
The images obtained indicated that 50 % of the absorbing plates presented corrosion bubbles, probably due the *internal corrosion under the external nickel layer*. The figure 9 shows bubbles corrosion at an absorbing plate.

Figure 9- Control Rod Bar - Ag-In-Cd neutron absorbing plate presenting bubbles corrosion under the nickel layer

The visual inspections showed the general conditions of the IEARI control rod bars. Following this work, it was recommended the substitution of the four actual control rods by new ones. This action is in progress.
