GAMMA RAYS IRRADIATION PROCESS ON A RESTORED PAINTING FROM THE XVIITH CENTURY

***Marcia M. Rizzo**^{1,2}, **Luci D.B. Machado**³, **Paulo R. Rela**³, **Yasko Kodama**³

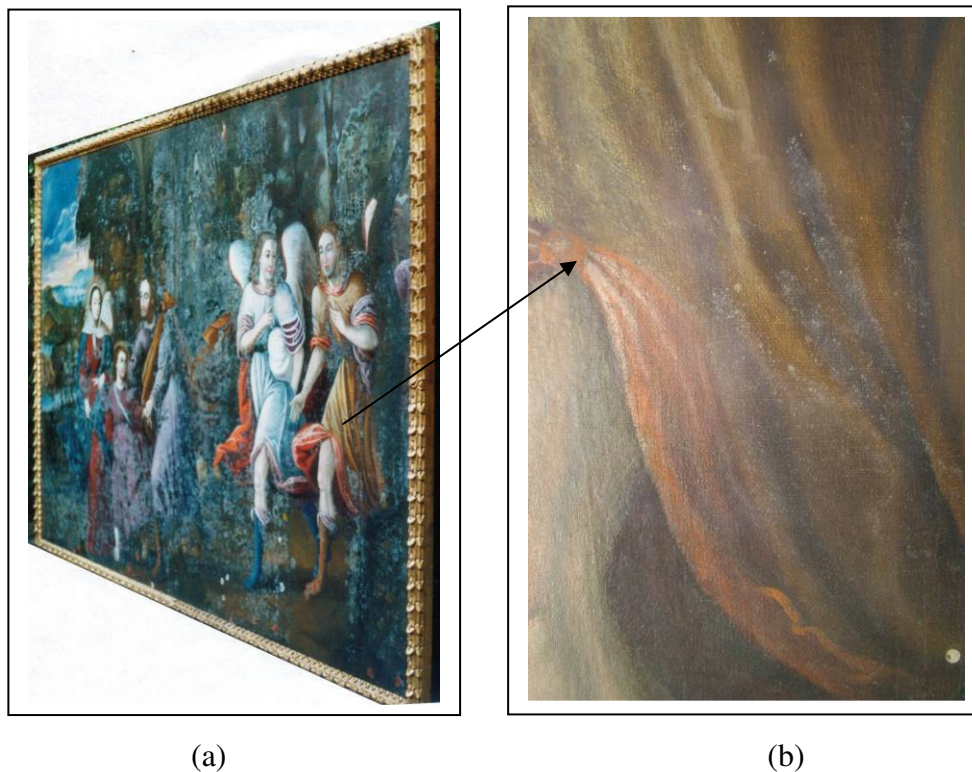
Six years latter it showed the beginning of the fungi growth again and the treatment with gamma radiation was proposed once more. But a painting is a complex system made by successive layers, each one composed by a lot of different materials. And it is well known that gamma radiation can interact with the molecular structure of the material changing its characteristics, especially those related to the color of pigments and chemical and physical properties of the polymers.

Figure 1. (a) 1st time contamination: photography with raking light took in angle to show almost 70% of the Peruvian painting covered by fungi some time after restoration. (b) 2nd time contamination: detail of the painting, showing the beginning of a new fungi growth in the painting layer.

The results obtained until now allowed concluding that the dose of 6 kGy do not killed all the fungi specimens in the painting. Since the fungi population was huge, probably some spore was not eliminated in the first irradiation process and germinated years later.

The studies of the painting materials behaviour made before the first time irradiation allowed us to decide the properly second time dose gamma radiation. The new gamma radiation dose used was 9 kGy totalizing 15 kGy, under what some modification in pigments or in polymers was found [4].

Both the box and the painting were cleaned again. All the apparent fungi residues were took out by mechanical process. The painting was put inside the acrylic box again, hermetically closed in order to prevent recontamination after the irradiation. But at this time the atmosphere inside the box was changed. Two roles with controlled valves were made in the diagonal extremes of the back side of the box. By them, the argon gas was injected inside the box creating an anoxic atmosphere with positive pressure. This micro atmosphere without oxygen is not favourable for the growth of the kind of fungi found in the painting [9] [1]. The argon gas is heavier than oxygen, therefore it is expected that it is more difficult to any molecule of oxygen go into the box, if any leakage happens. The valves will permit the future maintenance of the modified atmosphere by a regular change of the argon gas.

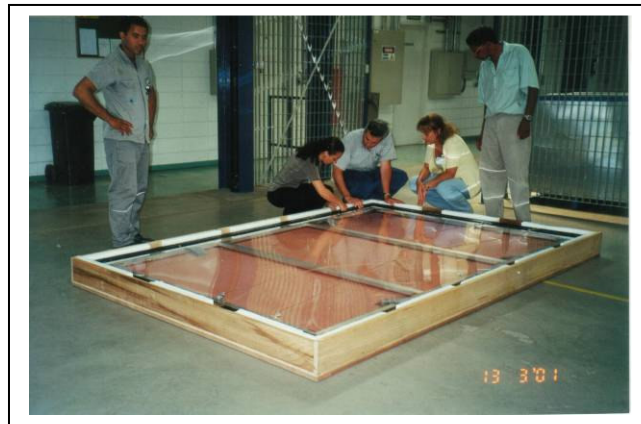
Figure 2. The back side of the painting with acrylic protection inside of the wood box lined with expanded polystyrene being observed before the first irradiation.

Before the irradiation procedure, the art work was cleaned. All the apparent fungi residues were took out by mechanical process, just to rescue the aesthetical appearance of the artwork. Because it is well know that this procedure doesn't eliminate the infestation. The painting was put inside an acrylic box, hermetically closed in order to prevent recontamination after the irradiation. The acrylic box with the painting was accommodated in a wood box lined with expanded polystyrene (Fig. 2). This entirely system was irradiated.

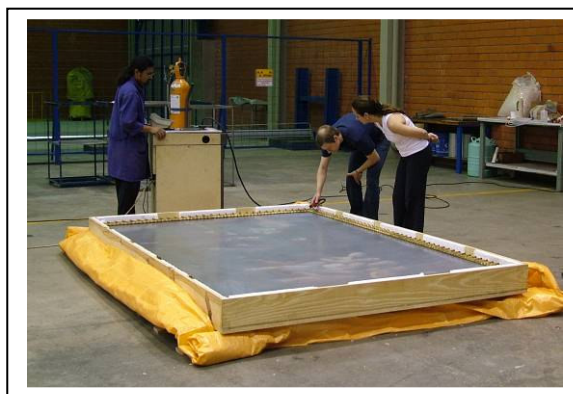
Figure 3. Checking the leakage of helium gas from the acrylic box by a Sniffer probe.

The possible recontamination of the painting caused by some fail in the seal of the acrylic box was checked by a Sniffer probe and no leakage was found. The system was intact. There is no evidence of that some news specimens entered in the system to caused a new growth of the colonies.
