EFFECT OF COUPON ORIENTATION ON CORROSION BEHAVIOR OF ALUMINIUM  
ALLOY COUPONS IN THE SPENT FUEL STORAGE SECTION OF THE IEA-R1 RESEARCH  
REACTOR

O.V.Correa, R.M.Lobo, S.M.C.Fernandes, G.Marcondes and L.V.Ramanathan

Instituto de Pesquisas Energéticas e Nucleares ( IPEN),

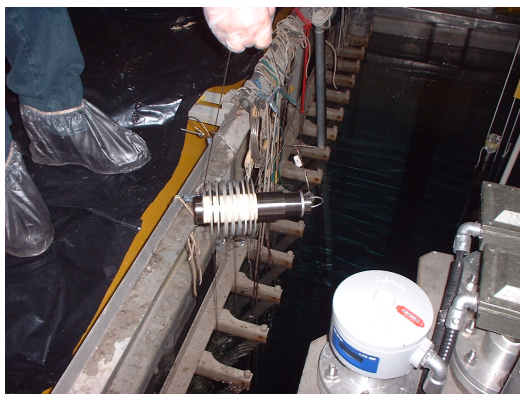
Figure 1. Photograph of rack with vertically oriented coupons being withdrawn from the storage section of the reactor pool.

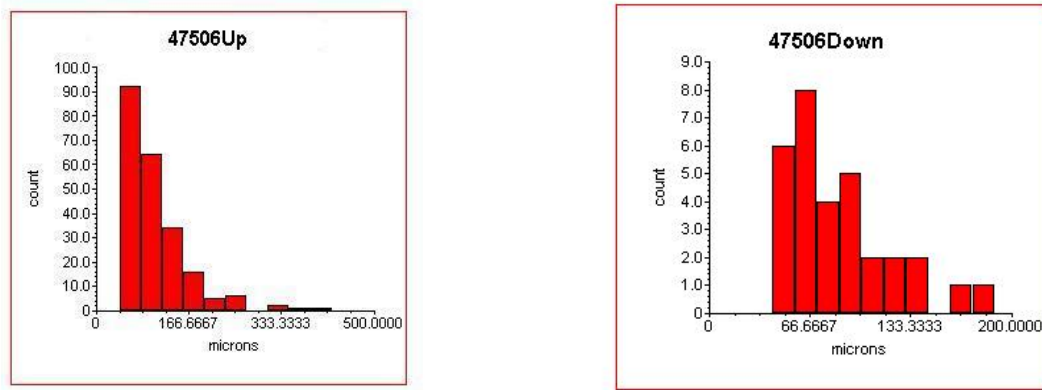
Figures 2a and 2b reveal the histograms of pit count versus pit size on the upward facing and the downward facing surfaces of the individual AA 1050 coupon respectively. The upward facing surface revealed a large number of pits, ~90, in the size range 40-50  $\mu\text{m}$  while the downwards facing surface revealed only 6-8 pits in the same size range. The shape of the pits on this coupon varied from irregular to round. (figure 3)

Figure 2. Histograms of pit count versus pit size on the upward facing (47506Up) and downward facing (47506Down) surfaces on horizontally oriented AA 1050 coupon.

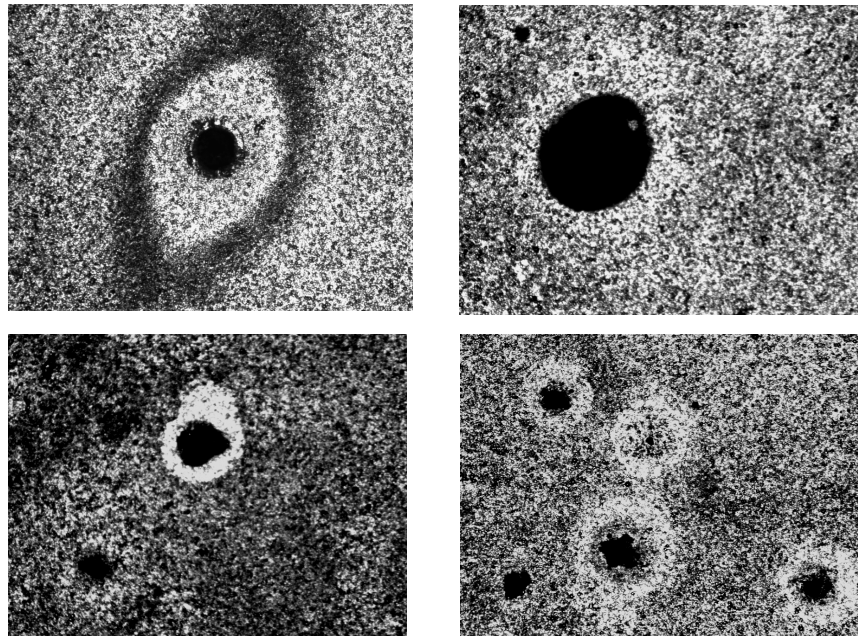
Figure 3. Micrographs showing pits and bright regions on horizontal AA 1050 surfaces.

Most of the pits revealed a bright region around the pit, characteristic of a cathode region around a localized anode region. The shape of this bright region also varied from circular to elliptical. (figure 3) On the exposed surfaces of the other AA 1050 coupons, similar round and irregular shaped pits were observed. On the AA 1050 coupon surface, in contact with the AISI 304 stainless steel coupon, large pits were observed, revealing the deleterious effect of a galvanic junction. The two surfaces of the pre-oxidized and scratched AA 1050 coupon revealed few small pits and no bright regions around the pits. No pits were observed along the scratch.

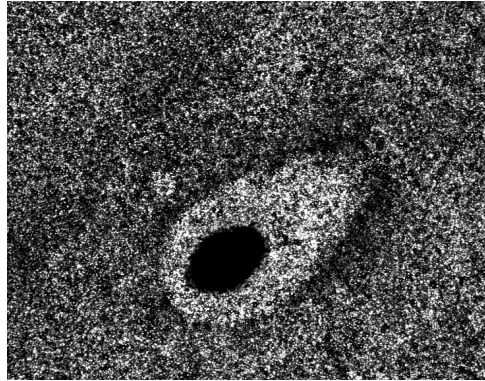
On the surfaces of the individual AA 1050 coupon, round and irregularly shaped pits were observed. Many pit clusters were also observed. The bright cathode areas associated with pits were shaped like a

comet with a tail giving a clear indication of the top and bottom of the vertically oriented coupons. (figure 4)

Figure 4. Optical micrograph of vertically oriented AA 1050 surface revealing comet shaped bright region around a pit.

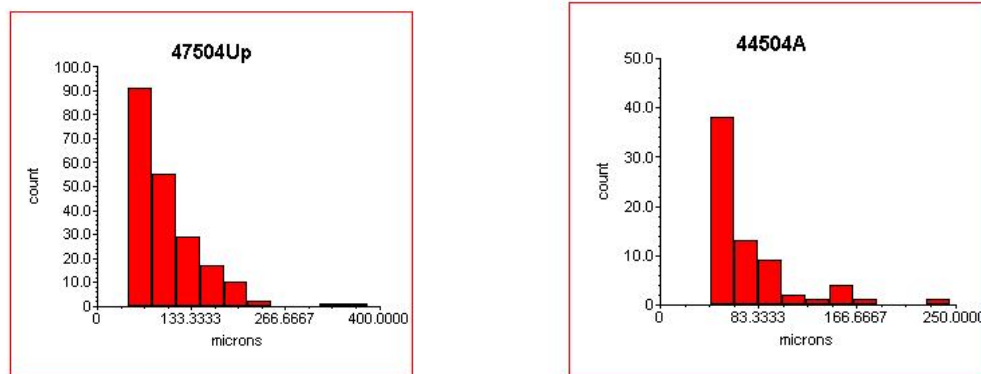
Comparison of pit histograms obtained for the horizontally oriented top surface of AA 1050 with that obtained for one of the surfaces of the same alloy oriented vertically (Figure 5) reveals that twice as many pits (size range 40-50  $\mu\text{m}$ ) form on the horizontal coupon as compared to that on the vertical coupon.

Figure 5. Histograms of pit count versus pit size on the upward facing surface (47504Up) and vertical surface (44504A) of AA 1050 coupon.

Comparison of histograms of the pitted surfaces of vertically and horizontally oriented AA 6061 alloy also revealed similar behaviour. This indicated that among the many parameters that control pit

formation, such as alloy composition, metallurgical state and water parameters, settled solids contribute to pit initiation and formation.
