IRRADIATED MTR FUEL ASSEMBLIES SIPPING TEST

J.A.Perrotta; L.A.A.Terremoto; C.A.Zeituni

Divisão de Engenharia do Núcleo
Instituto de Pesquisas Energéticas e Nucleares. IPEN-CNEN/SP
Travessa R 400 - Cidade Universitária
São Paulo - SP - Brasil - 05598-900
E-mail: perrotta@net.ipen.br

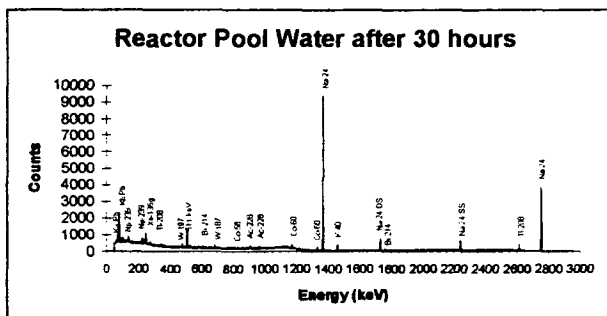
Figure 4 . Pool Water Sample Gamma-Ray Spectrum

A sample of pool water was also collected to serve as general gamma-ray background survey.

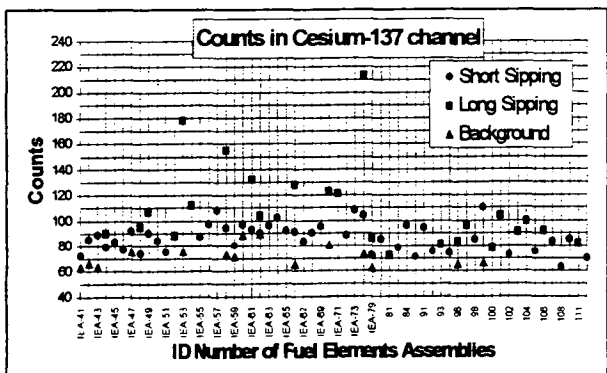
Figure 6 . Fuel Assemblies Sipping Water Samples Counting Results.

Figure 6 shows the counts of the ^{137}Cs energy channel for every fuel assembly analyzed. It can be seen that the background analysis for that fuel assembly with no indication of ^{137}Cs shows a base level of counts between 60 and 85 (for 4000 sec). For those fuel assemblies that indicate the ^{137}Cs photopeak the counts are higher than 90.

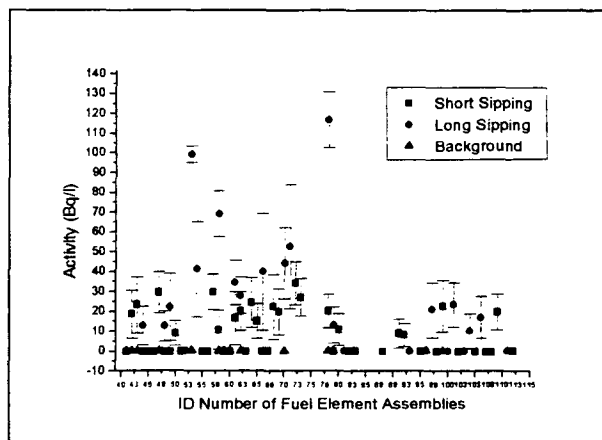
Figure 7 . Fuel Assemblies Sipping Water Samples Activity Results.

Figure 7 shows the specific activity calculated for each fuel assembly sipping test. It can be noticed that some fuel assemblies show a leaking pattern, and that most of fuel assemblies have specific activities lower than 30 Bq/l (for sipping resting time of 4 hours).

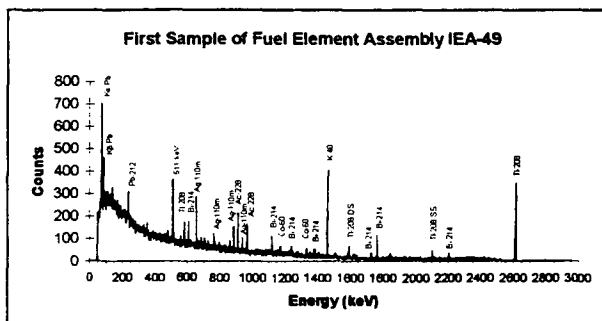
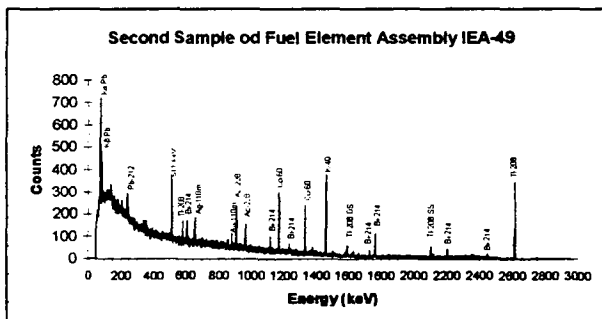
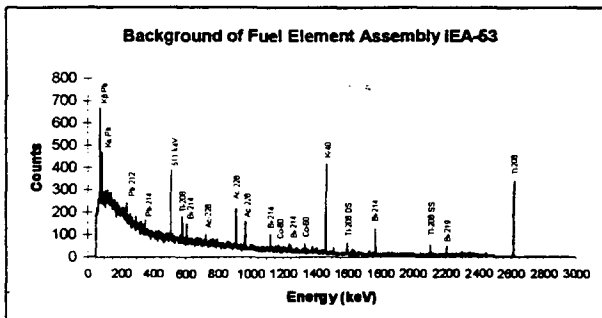
Figures 8,9,10 and 11 show the gamma spectra for one nonleaking or very low leaking fuel assembly (IEA-49) and one leaking fuel assembly (IEA-53), showing also the difference in the background spectra.

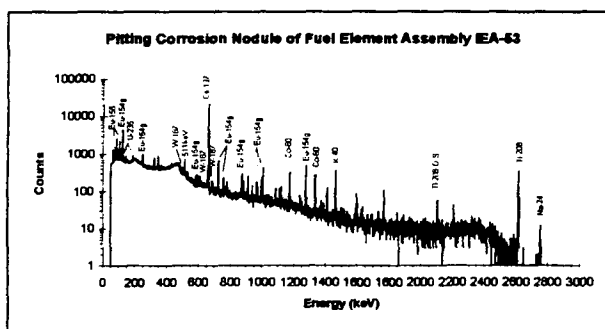
Figure 14 . Pitting Corrosion Nodule-Gamma Ray Spectrum

A sample of a pitting corrosion nodule from a fuel plate was taken to perform gamma-ray spectrometry analysis. Figure 14 shows the gamma-ray spectrum obtained. One can find a large activity of ^{137}Cs and also activities of ^{235}U , ^{155}Eu , and ^{154}Eu . This indicates that the pitting corrosion nodule penetrates through the cladding up to the plate meat where there is uranium and fission products. Also indicates that besides ^{137}Cs , U and Eu isotopes are migrating from the meat to the nodule. U and Eu are not migrating (or migrating in a very small rate) to the water, though this elements were not found in the gamma-ray spectrometry of the sipping water. This mechanism of U and F.P. migration from the plate meat through the corrosion pit to water (migration / solubility / diffusion / chemical compounds / chemical reaction / etc.) has to be more deeply studied.

The activity of ^{137}Cs in the pitting corrosion nodule sample was determinate to be 2400 Bq or 5600 Bq/g. It is interesting to compare this activity with the meat activity and the sipping water activity.

There is a migration of ^{137}Cs from the meat to the water, with a retention at the pitting corrosion nodule, with a leaking rate of orders of magnitude below the meat activity.

- Pitting corrosion nodule gamma-ray spectrometry shows the occurrence of Cs, U and Eu isotopes. The ^{137}Cs activity is much higher than the sipping water activity and U and Eu isotopes were not detected in water. This confirms that it is a thru-clad pit.
