EFFECT OF COUPON ORIENTATION ON CORROSION BEHAVIOR OF ALUMINIUM  
ALLOY COUPONS IN THE SPENT FUEL STORAGE SECTION OF THE IEA-R1 RESEARCH  
REACTOR

O.V.Correa, R.M.Lobo, S.M.C.Fernandes, G.Marcondes and L.V.Ramanathan

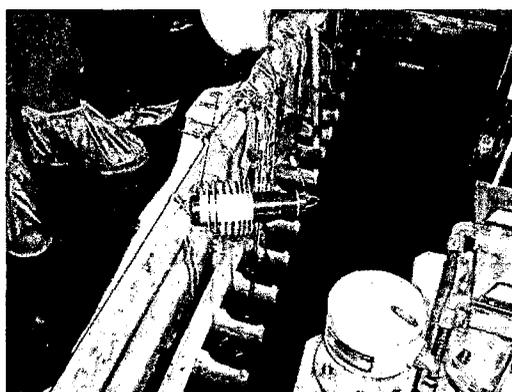
Figure 1. Photograph of rack with vertically oriented coupons being withdrawn from the storage section of the reactor pool.

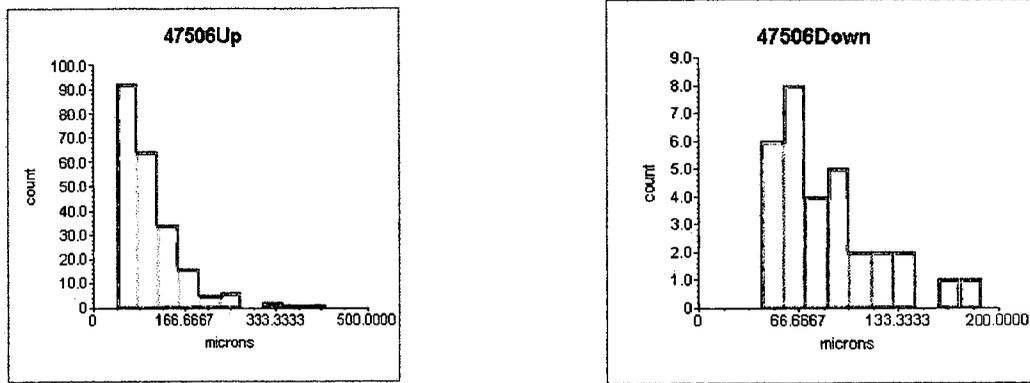
Figures 2a and 2b reveal the histograms of pit count versus pit size on the upward facing and the downward facing surfaces of the individual AA 1050 coupon respectively. The upward facing surface revealed a large number of pits, ~90, in the size range 40-50  $\mu\text{m}$  while the downwards facing surface revealed only 6-8 pits in the same size range. The shape of the pits on this coupon varied from irregular to round. (figure 3)

Figure 2. Histograms of pit count versus pit size on the upward facing (47506Up) and downward facing (47506Down) surfaces on horizontally oriented AA 1050 coupon.

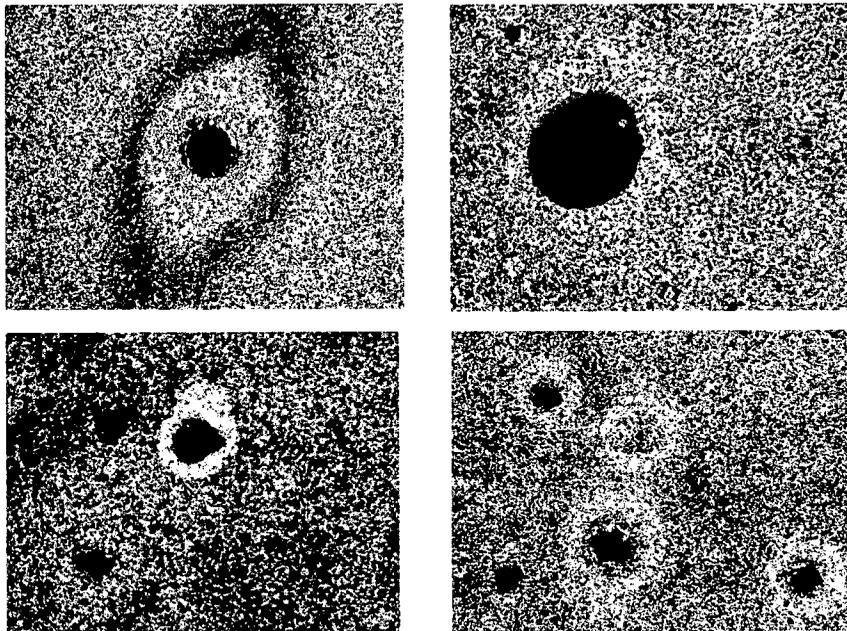
Figure 3. Micrographs showing pits and bright regions on horizontal AA 1050 surfaces.

Most of the pits revealed a bright region around the pit, characteristic of a cathode region around a localized anode region. The shape of this bright region also varied from circular to elliptical. (figure 3) On the exposed surfaces of the other AA 1050 coupons, similar round and irregular shaped pits were observed. On the AA 1050 coupon surface, in contact with the AISI 304 stainless steel coupon, large pits were observed, revealing the deleterious effect of a galvanic junction. The two surfaces of the pre-oxidized and scratched AA 1050 coupon revealed few small pits and no bright regions around the pits. No pits were observed along the scratch.

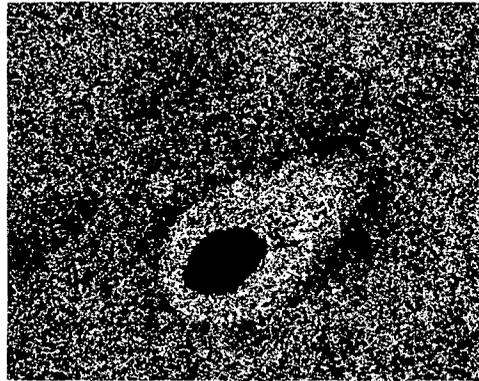
On the surfaces of the individual AA 1050 coupon, round and irregularly shaped pits were observed. Many pit clusters were also observed. The bright cathode areas associated with pits were shaped like a

comet with a tail giving a clear indication of the top and bottom of the vertically oriented coupons. (figure 4)

Figure 4. Optical micrograph of vertically oriented AA 1050 surface revealing comet shaped bright region around a pit.

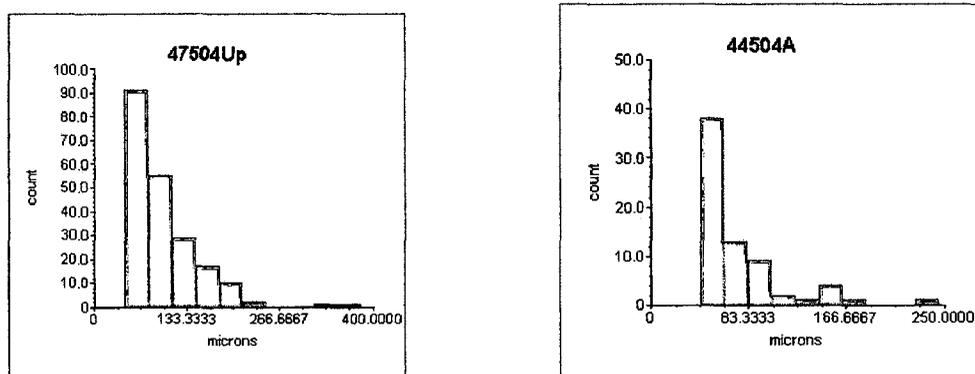
Comparison of pit histograms obtained for the horizontally oriented top surface of AA 1050 with that obtained for one of the surfaces of the same alloy oriented vertically (Figure 5) reveals that twice as many pits (size range 40-50  $\mu\text{m}$ ) form on the horizontal coupon as compared to that on the vertical coupon.

Figure 5. Histograms of pit count versus pit size on the upward facing surface (47504Up) and vertical surface (44504A) of AA 1050 coupon.
