SPENT FUEL ASSESSMENT, ISOLATION OF LEAKERS, STUDIES WITH CORROSION COUPONS AND PREPARATIONS FOR SHIPMENT ABROAD

Lalgudi V.Ramanathan

Instituto de Pesquisas Energeticas e Nucleares Energy and Nuclear Research Institute Travessa R-400, Cidade Universitaria 05422-970 São Paulo. Brazil

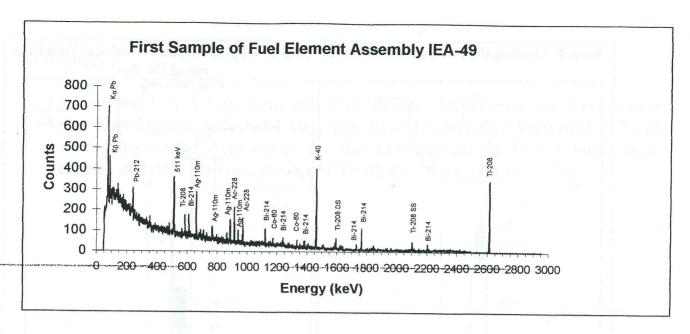
Figure 3. Gamma-Ray Spectrum of water sample from sipping test of FA-49

fuel assemblies showed the ¹³⁷Cs photopeak; (b) fuel assemblies for which two water samples were takeni showed an ncrease in activity with time. This indicated that the fuel assembly was leaking. It is possible to determine the leak rate of ¹³⁷Cs for the FA. For example, for the fuel assembly IEA-53 this rate was ~0.2 Bq/l.min or ~14 Bq/min. Figure 2 shows the specific activity for each fuel assembly in the sipping test. Some fuel assemblies showed leaks, and most of the FAs had specific activities lower than 30 Bq/l (water residence time of 4 hours). Figures 3 and 4 show the gamma spectra for a non-leaking and a leaking FA respectively.

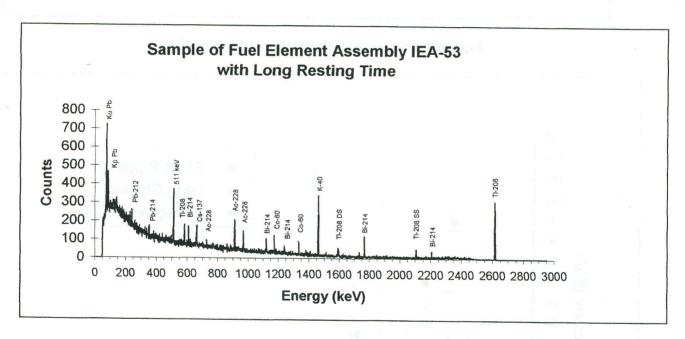
Figure 4 - Gamma-Ray Spectrum of water sample from sipping test of FA-53

FA IEA-53 had the highest leak rate, of 14 Bq/min, and this was less than the value established by DOE-SRS for canning leaking fuel assemblies. The DOE-SRS interim criteria was 13.57 μCi/hr per cask to be shipped, which is equivalent to 35.9 pCi/ml.hr for one fuel assembly (assuming 3.6 gallons of water per fuel assembly). The value obtained at IPEN in the sipping tests when corrected to the volume of SRS criteria, was 0.64 pCi/ml.hr (0.4 Bq/l.min.), well below the criteria limit. The DOE interpretation of Foreign Research Reactor Environmental Impact Statement (FRR.EIS) stipulated that any fuel that contained a thru-clad pit should be canned for shipment and storage. Eventhough the IPEN sipping test data met the DOE criteria, they imposed some restraints due to the corrosion pits and their distribution. According to this some of the FA had to be canned eventhough they passed the criteria. This requirement was subsequently withdrawn.

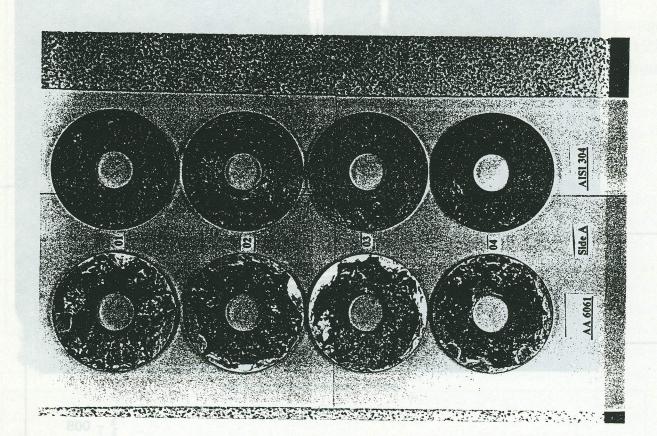
- The uncoupled AA6061 and AA6262 specimens had fewer pits than uncoupled AA1060 specimens.
- The top surfaces of uncoupled specimens had more pits than their under sides, due to dust settling
- Crevice surfaces of 1060/1060, 6061/6061and 6061/1060 couples were stained but not pitted. (Figures 7)
- The surfaces of the aluminium alloys within the crevices of 6061/304SS and 6262/304SS couples were heavily pitted, indicating increased corrosion of aluminium coupled to stainless steels. The steel surfaces were only stained and revealed rust marks. (Figure 8)
- The 1060 surface within the crevice of 1060/304SS couple was stained but not pitted.
