Safety and Security issues during the return of contaminated scrap metal to Brazil

M. C. ALMEIDA¹, P. R. PERROTTA², R. SANTOS³, D. A. ANDRADE⁴, M. A. V. WASSERMAN⁵

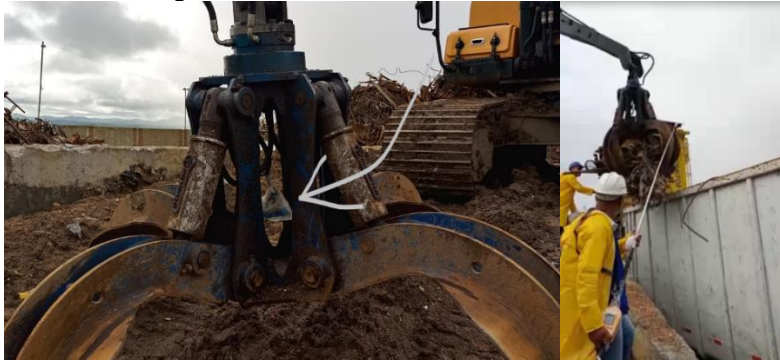
With the container positioned in the company's yard, the operation began. After 18 removals with a mechanical winch shovel (figure 1) – each removal being monitored – the emission source was identified using a detector protected and positioned, like a pendulum, in the claw that removed the material (figure 1). The detector warned when the emission source was found, which was confirmed by a professional, who was positioning a rod with another detector (figure 2). After removal with detection, the material was segregated, and the source

was then found; identifiers gauged dose values previously obtained, confirming Ra-226 emission. Characterized as a source for industrial use: a lightning rod with Ra-226. It was then placed into a container and transported to the Northeast Regional Center for Nuclear Sciences.

Figures 1 and 2 – Respectively, arrow indicating the packed detector, attached to the winch claw; and measurement made with rod.
