## Failure Analysis of an Automotive Component (Cardan Yoke) by Scanning Electron Microscopy

**Abstract.** Two SAE 1541 (0.39%C; 1.44%Mn; 0.23%Si; 0.16%Ni; 0.16%Cr) carbon steel cardan yokes that were forged, machined, quenched and tempered, as part of the manufacturing process to ensure long term operation under specific loading conditions, failed during its manufacture. The cardan yokes ruptured in the bearing seat region while these were being straightened by bending. This study deals with fracture analysis that was carried out by visual inspection and scanning electron microscopic examination. The focus of this study was to investigate the fracture mechanism associated with the failures. Fractographs of the broken components indicated that the rupture initiated at the edges of the component, from preexisting cracks, due to the bending stresses during the straightening process. The initial stage of rupture was predominantly intergranular in the tempered martensite surface layer, revealing the brittle nature of the component. Cracks were observed at regions prone to stress concentration. Eventual rupture of the component probably initiated at these cracks. This behavior is proba

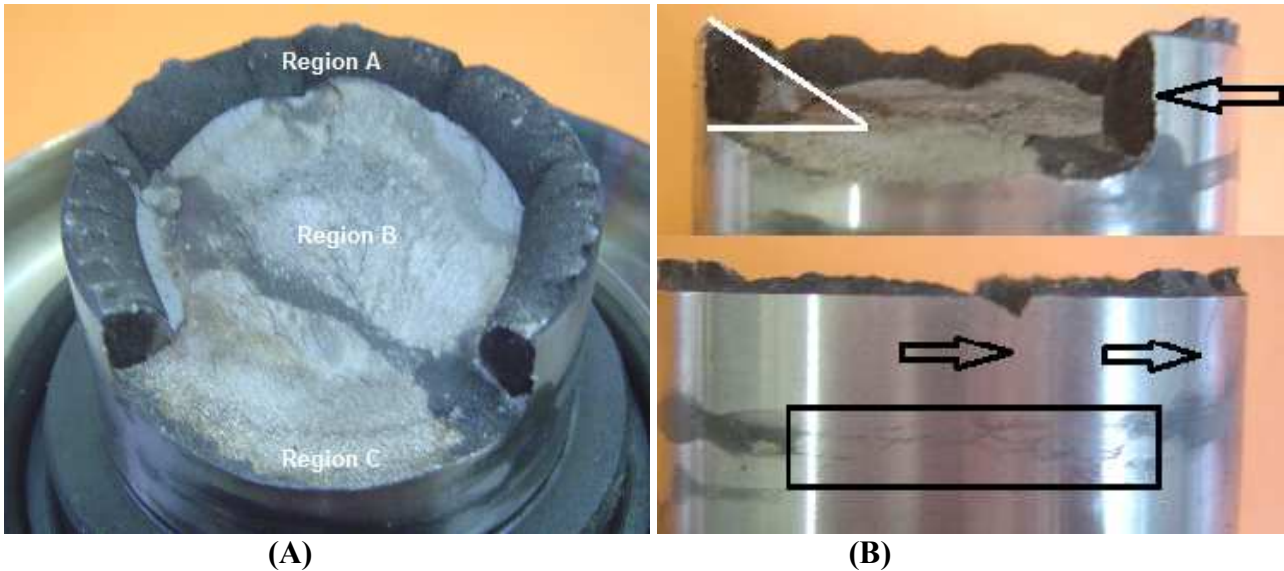
Failure of the two cardan yokes will be discussed separately. Figure 1A shows a general view of the fracture surface of one of the cardan yokes. The initial crack, caused by the heat treatment process occurred at region A. During the straightening process, the crack propagated into region labeled B, which revealed radial marks. The final fracture stage, labeled as C in figure 1A, spread all over the fracture surface, including the periphery, except region labeled A. This final fracture occurred at an angle of approximately 45° with respect to region B. The dark surface in region C is attributable to

the temper heat treatment in a preexisting crack. Figure 1B shows a side view of the failed component and the white lines indicate the 45° angle, mentioned previously. The circumferential cracks, shown within the black rectangle in figure 1B are probably related to the original flaws and responsible for the manufacturing process failure. The black arrows in this figure point at some vertical cracks indicating the fracture path.

Figure 1: (A) General view of the fracture surface of a cardan yoke. (B) Side views of a fractured cardan yoke.

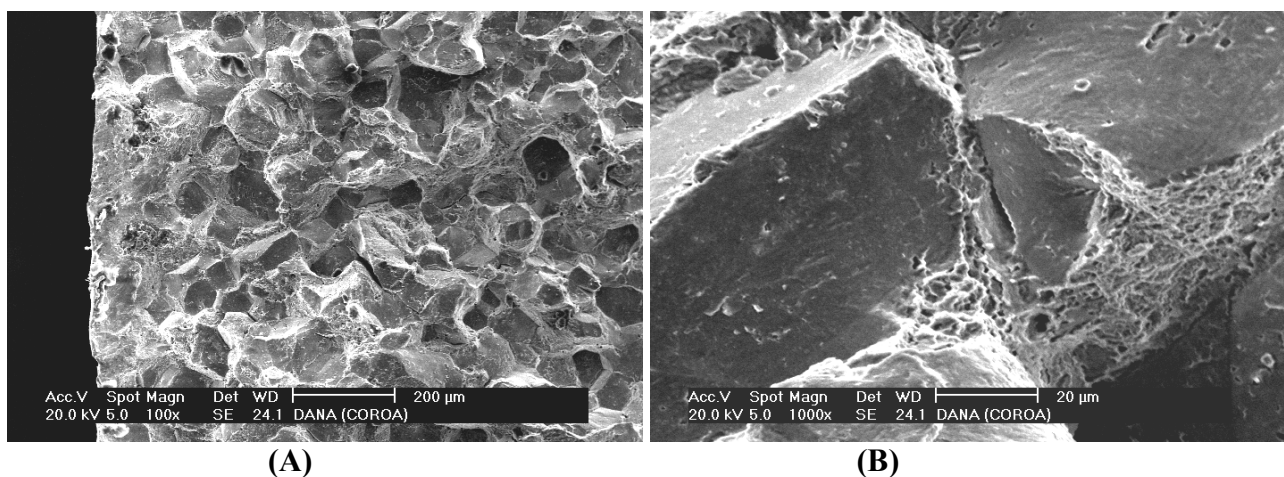
Detailed fracture surface micrographs obtained with a scanning electron microscope can be seen in Figures 2 to 5. Figures 2 and 3 are micrographs of region A of figure 1A. The scanning electron micrographs in figure 2 were taken from the edge of the initial crack. This reveals an intergranular cracking process with some dimples caused by some intergranular precipitates (figure 2B). Figure 3 shows a micrograph of region A, and reveals an intergranular fracture mode, but with grain size smaller than that seen at regions where fracturing started.

Figure 2: Scanning electron micrographs of the initial crack region of a cardan yoke fracture surface.

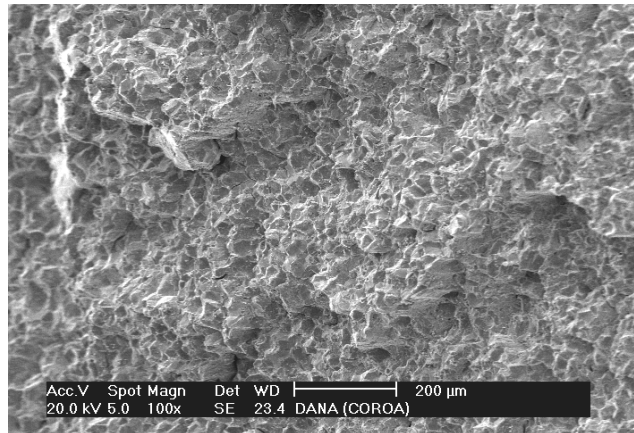
Figure 3: Scanning electron micrograph of an area close to the initial crack region on a cardan yoke fracture surface.

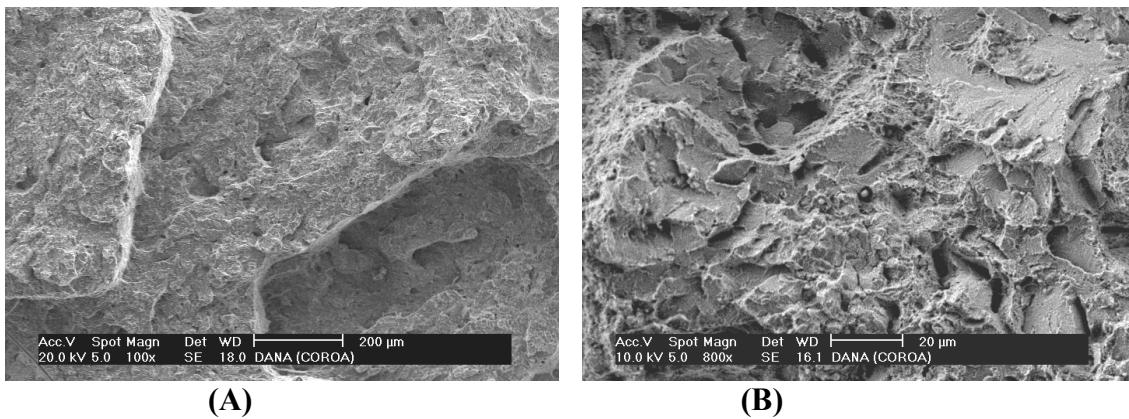
Fracture features of region B (of figure 1) are shown in figure 4. Figure 4A reveals that the fracture path followed different planes. Figure 4B reveals a micrograph illustrating a mixed mode fracture mechanism, with a dimpled area that could be attributed to a quasi-cleavage fracture. Figure 5 is a micrograph of region C, and reveals an intergranular fracture pattern, similar to that in region A.

Figure 4: Scanning electron micrographs of the central region of a cardan yoke fracture surface.

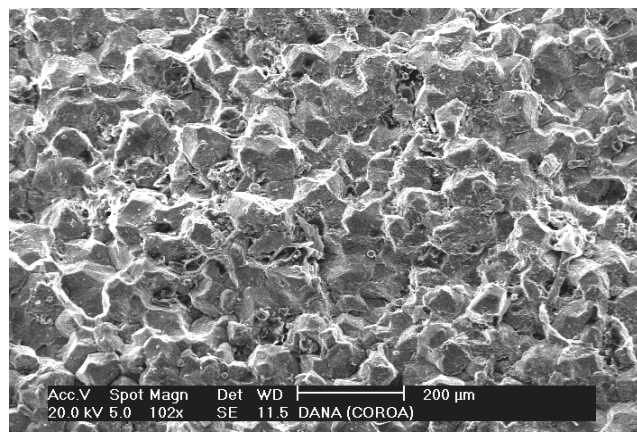
Figure 5: Scanning electron micrograph of the region of a cardan yoke fracture surface where cracking terminated.

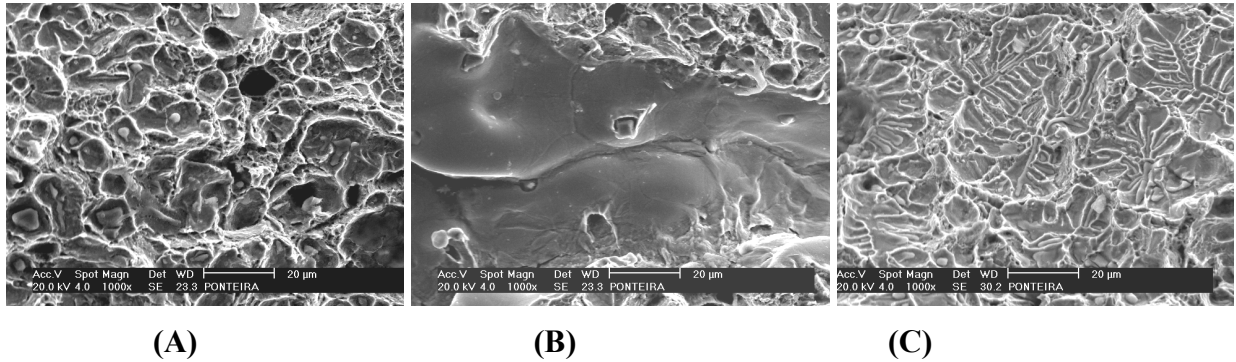
Figure 6 presents fracture surface features of region C. Figure 6A shows just the presence of microvoids. Figure 6B shows a large flat region with some inclusions, adjacent to the region with the microvoids. In figure 6C elongated inclusions and microvoids with cellular morphology can be seen. An optical micrograph of a cross section of the fractured area is shown in Figure 7. The

Figure 6: Scanning electron micrographs of the central region of a cardan yoke fracture surface. (Region C in figure 1A).

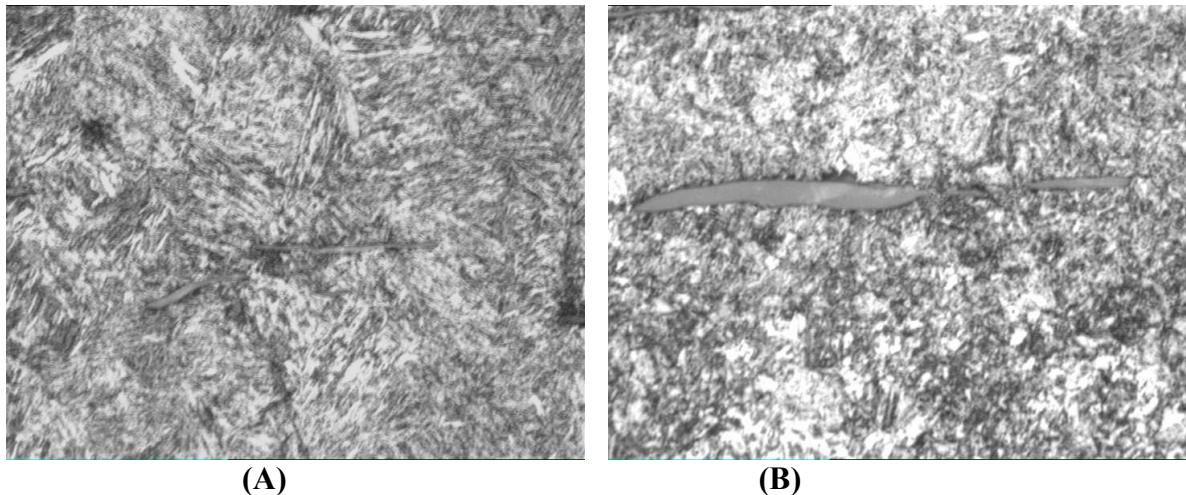
microstructure in the induction hardened area, close to the surface, shows a tempered martensite structure. Further inside, the structure becomes bainitic as shown in figure 7B. Elongated sulfide inclusions can be observed in both micrographs. A banded structure can be seen in the other region (figure 8).

Figure 7: Optical micrographs of the cardan yoke in the induction quenched region (A) and in the center (B), revealing sulfide inclusions.

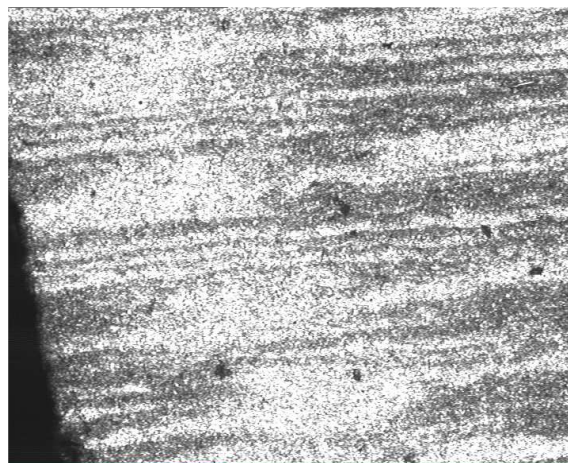
Figure 8: Optical micrograph revealing a banded structure.

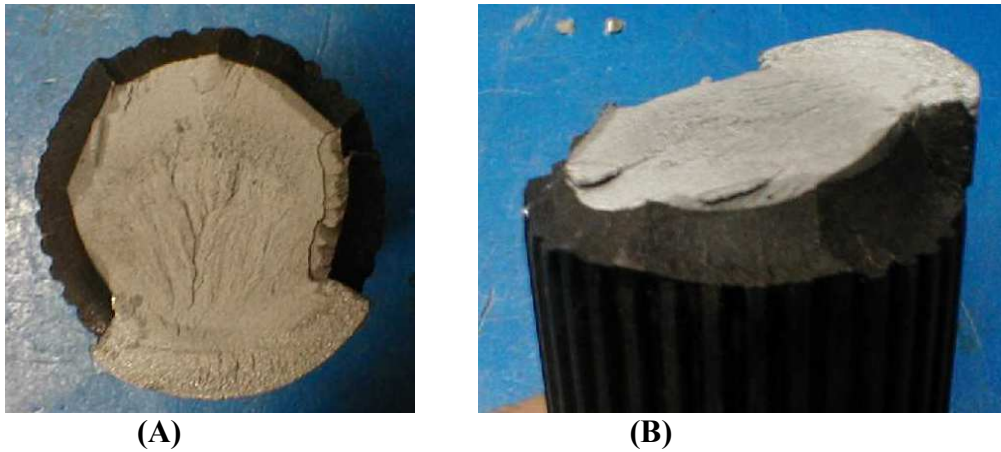
Figure 9 shows a general and lateral view of the fracture surface of the second cardan yoke. The fracture took place in the final of the splines, close to the bearing seat during the bending operation. The fracture started in the undercut, between the spline final and the bearing seat, spreading to

almost all the external component diameter (spreading right across the section of the component). The darkened fracture surface suggests that the fracture occurred before the tempering heat treatment. The microstructure in the bearing seat was due to the induction hardening treatment and consisted of tempered martensite as shown in Figure 10. However, cross sectional microstructure analysis of the fractured area revealed a banded structure with bainite plus martensite in the inner part of the component. This had hardness higher than the maximum specified for this application (50 to 61 HRC), which could be attributed to the higher carbon content in the segregated banded structure, shown in Figure 11.

Figure 9: (A) General view of the cardan yoke fracture surface, showing a dark ring-shaped nail, indicating a pre-existing crack. (B) Lateral view of the cardan yoke fracture surface.

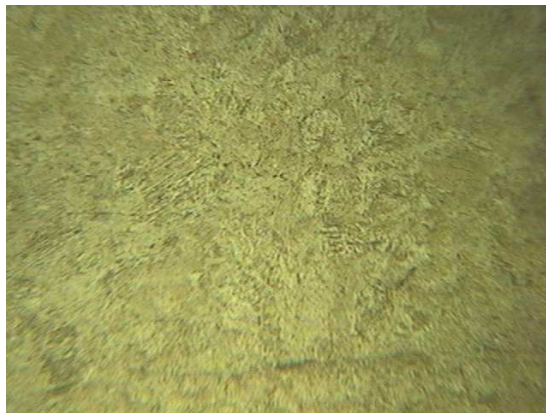
Figure 10: Typical micrograph of the cardan yoke tempered by induction.

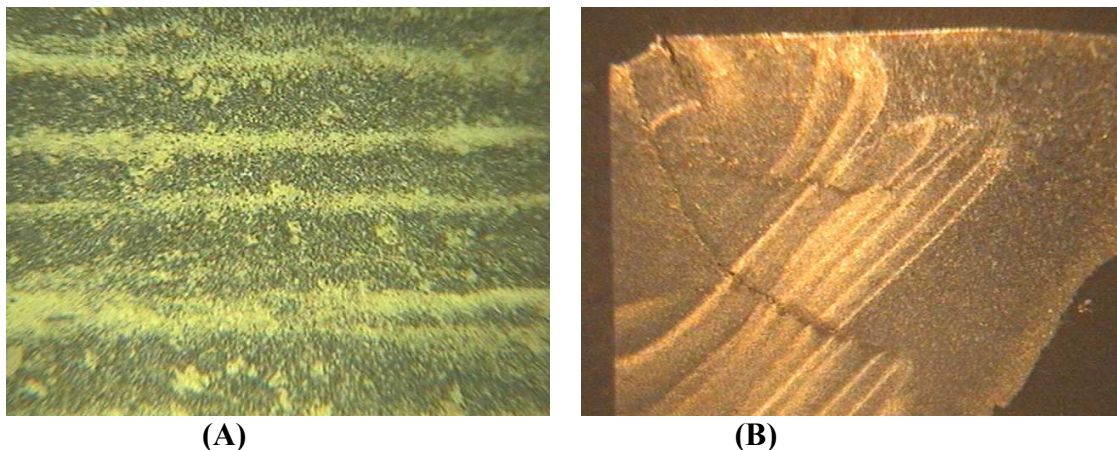
Figure 11: (A) Typical micrograph of the cardan yoke, revealing a banded structure. (B) Macrograph of the fracture region, which shows superimposed martensite layers (banding).
