XXVI Congresso Brasileiro de Física Médica
IX Congresso Latino Americano de Física Médica
Fortaleza – Brasil
07 a 11 de junho de 2022

RDC 330 IN PRACTICE: ANALYSIS OF THE CHALLENGES OF IMPLEMENTING NORMATIVE INSTRUCTION 97 IN THE PRIVATE MAGNETIC RESONANCE CLINICS OF THE CITY OF FORTALEZA-CE.

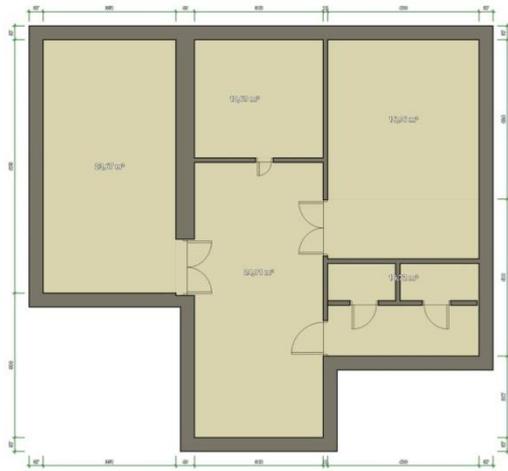
Figure 1A: Blue Print Location 1

We can observe in Figure 1A the blue print of location 1, we can analyze that the resonance door already opens to an area of free movement, having an absence of zone 3, and there may be accidents due to this failure, with this was elaborated a projection of how the service could demarcate these zones as we can see in Figure 1B, also the use of a metal detector was not detected at the entrance of the equipment room.

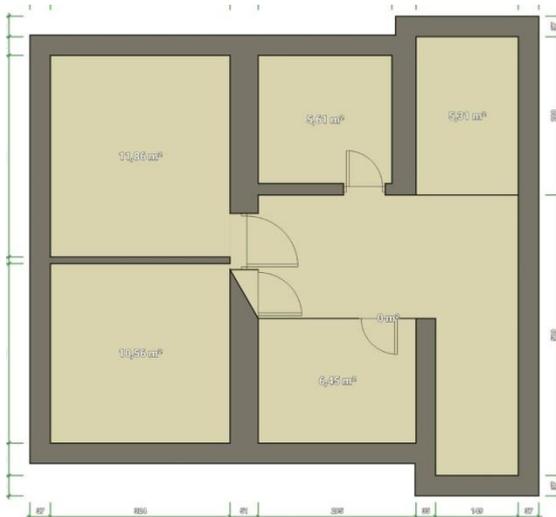
Figure 2A: Blue Print Location 2

Location 2 resonance equipment has a lower magnetic field than the others, not requiring such a large room, but as we can analyze in Figure 2A the zoning system is not obeyed, besides there is no metal detector in the clinic. Once the necessary observations were made, a blue print was prepared with the zoning system well defined as requested by IN 97.

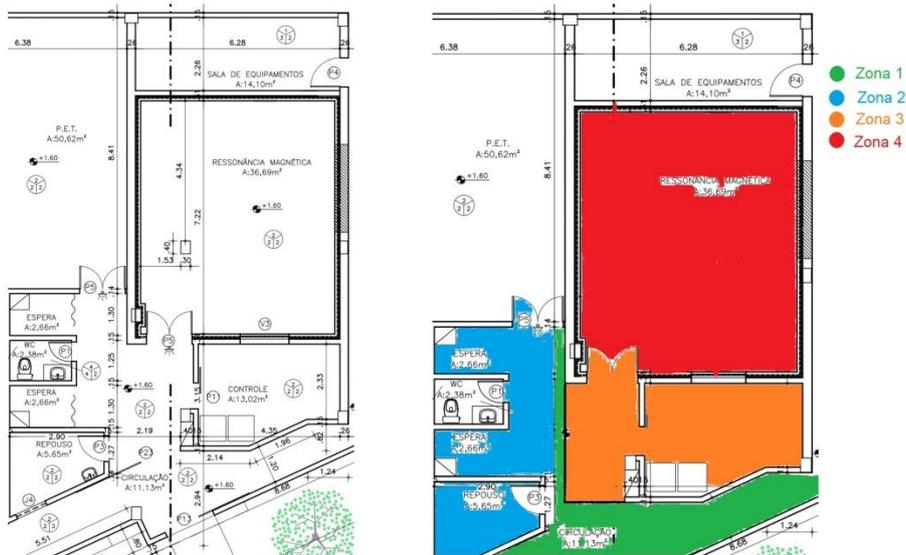
Figure 3A: Blue Print Location 3

This center is the one that is in agreement with the regulations, in Figure 3A has the first blue print, after going through a consulting with a radiological protection supervisor, they adapted their installation by purchasing the metal detector and elaborating a zoning according to Figure 3B.

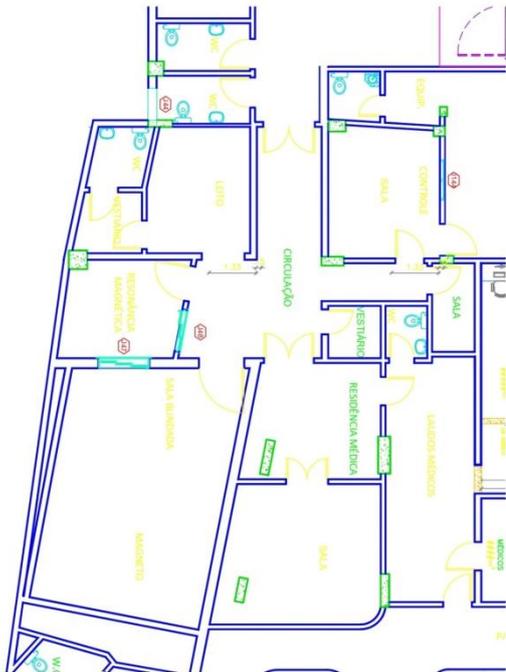
Figure 4A: Blue Print Location 4

In Figure 4A we can observe the blue print of the Location 4 analyzed in this work. As we analyze the resonance centers divides its space with other hospital services, we have the medical residency that access passes through the resonance center, in addition to other administrative services. It is also perceptible in the center that there is no zoning according to the rules of health surveillance, we do not have a well-defined zone 3 this is in accordance with normative instruction number 97 that states "Art. 9º The health service must have a system of detection of metals for monitoring the access of people and objects to zones III and IV in quantity compatible with the number of examination rooms." (Normative Instruction 97 of 05/27/2021 of AN-VISA), thus generating the impossibility of having a control using metal detector as requested. No metal detection devices were also found at the scene.

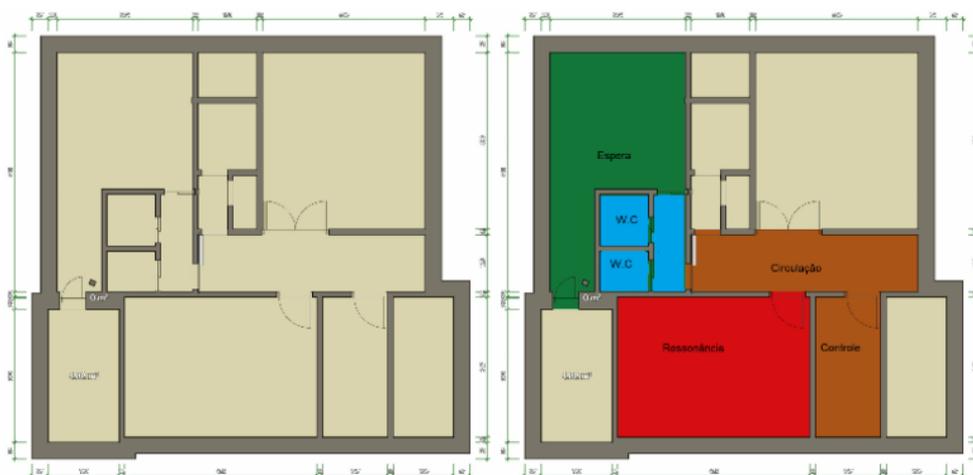
Figure 5A: Blue Print Location 5

In location 5, its entire structure was already ready for zoning, just needed to make clear where each zone was and acquire a metal detector as we can see in Figure 5A. With this was elaborated from your blue print how would the service zones system look, as we can analyze in the Figure 5B.
