Corrosion of Aluminium-clad Spent Research Reactor Fuel in Wet Storage

Abstract

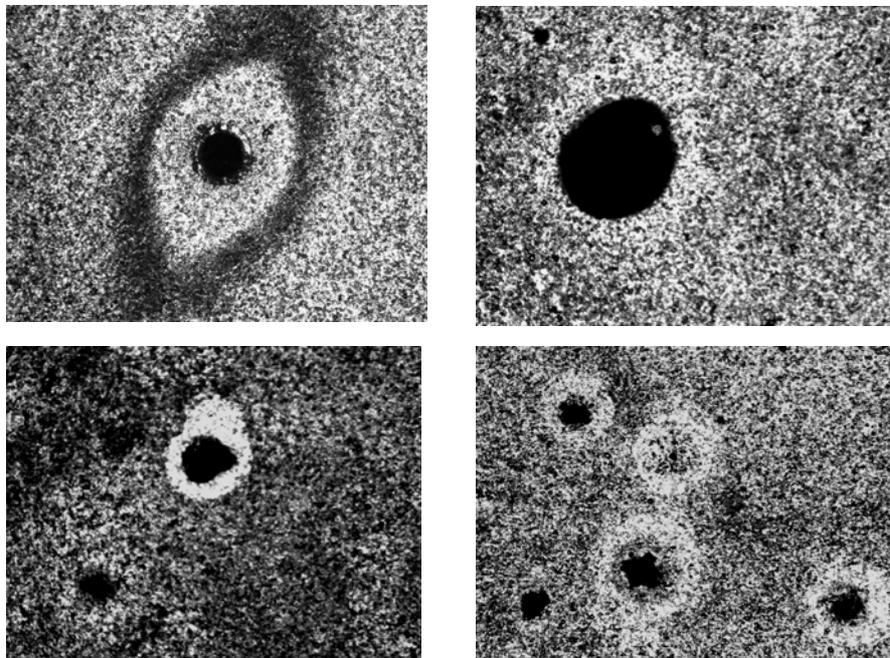
Comparison of pit features on horizontal and vertical coupons revealed that the bright regions around pits on vertically oriented coupons were shaped like a comet with a tail, unlike those around pits on a horizontal coupon, giving thereby a clear indication of the top and bottom of the vertically oriented coupons. (figure 3) Almost all the pit features and the comet shaped bright areas associated with the circular pits, on AA 1050 were also observed on the exposed surfaces of AA 6061 coupons.

Figure 2. Micrographs showing pits and bright regions on horizontal AA 1050 surfaces.

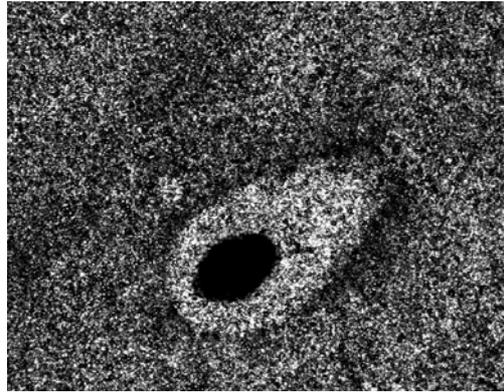
Figure 3. Optical micrograph of vertically oriented AA 1050 surface revealing comet shaped bright region around a pit.

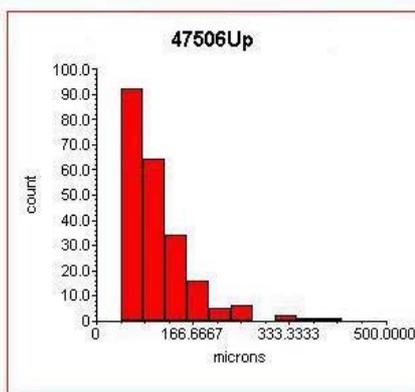
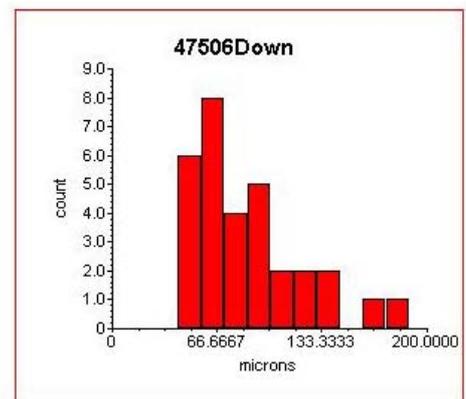
Figure 4. Histograms of pit count versus pit size on the surface facing upwards: (a) 47506Up and facing downwards (b) 47506Down on horizontally oriented AA 1050 coupon.

Figures 4a and 4b reveal the histograms of pit count versus pit size on the surface facing upwards and the surface facing downwards of the individual AA 1050 coupon respectively. The surface facing upward revealed a large number of pits, ~90; in the size range 40-50 μm while the surface downwards revealed only 6-8 pits in the same size range. The shape of the pits on this coupon varied from irregular to round.

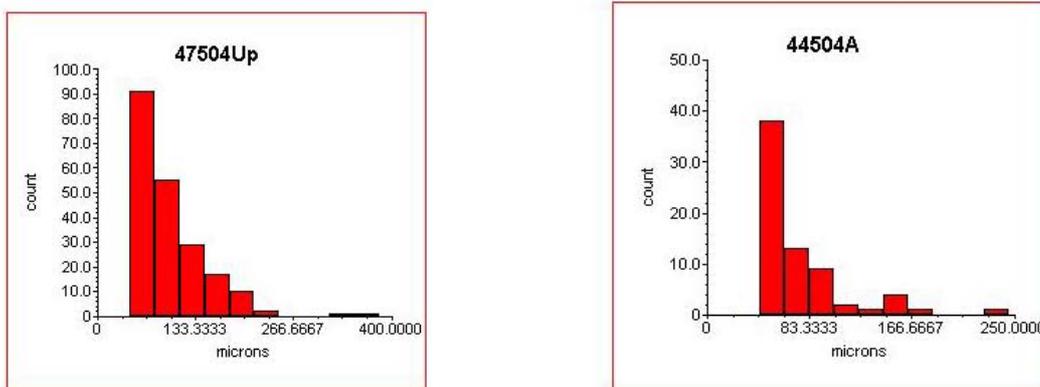
Comparison of pit histograms obtained for the horizontally oriented top surface of AA 1050 coupon exposed for one year, with that obtained for one of the surfaces of the same alloy oriented vertically (Figure 5) revealed that twice as many pits (size range 40-50 μm) form on the horizontal coupon as compared to that on the vertical coupon.

Figure 5. Histograms of pit count versus pit size on the upward facing surface (47504Up) and vertical surface (44504A) of AA 1050 coupon.

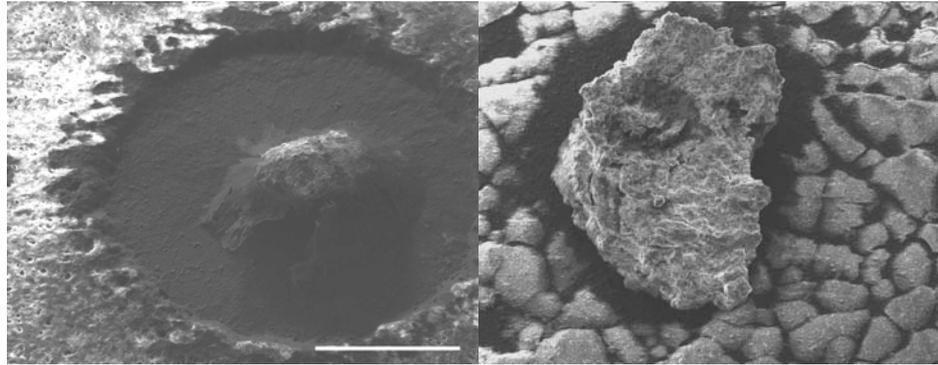
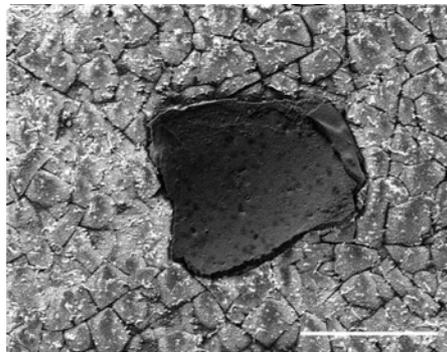
Complementary laboratory tests were carried out at CNEA, Argentina, to determine the role of certain sediments such as concrete, hematite and magnetite on the corrosion of AA 6061 exposed to high purity water (1.2μS/cm conductivity) with pH in the range 5.5 – 6.9 for 40 days. Figure 6 shows the features of pits that form on the AA 6061 surface associated to the presence of the deposited particle. The nature of the sediment influenced the extent of corrosion of Al. Attack of the surface with the cement particles was evident after 2 days. Figure 6a shows the moat with the thin oxide around the cement particle and further away the thick oxide ring. The surface with iron oxide (hematite) and as shown in figure 6b is attacked where as the surface with magnetite is unattacked.(figure 6c)

Figure 6. Micrographs of surfaces of deposit containing AA 6061 exposed to high purity water for 40 days: (a) concrete, (b) hematite and (c) magnetite
