## NON DESTRUCTIVE TESTING OF IRRADIATED FUEL ASSEMBLIES AT THE IEA-R1 RESEARCH REACTOR

Instituto de Pesquisas Energéticas e Nucleares (IPEN / CNEN - SP)  
Av. Professor Lineu Prestes 2242  
05508-000 São Paulo, SP

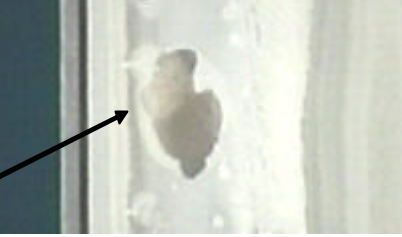
**Figure 5 – Example of a data sheet of the fuel element IEA-158 [7]**

| Facility Name: <b>IEA-R1 Research Reactor</b> | | | Country: <b>BRAZIL</b> | <b>IEA-158 (cont.)</b> |
|---|---|---|---|---|
| <br>Side 3 – upper view | <br>Side 2 – Sequence upper, central and bottom view | <br>Side 4 – Sequence upper, central and bottom view | <div style="border: 1px solid black; padding: 5px;"> <b>General Remarks</b><br/> 1- Date of Visual Inspection: 12/11/04<br/> 2- Lateral plates presents oxide surface regions<br/> 3- At central region, thin thickness of aluminum oxide layer was lost<br/><br/> <div style="display: flex; justify-content: space-between;"> <div>Date<br/><b>12/11/04</b></div> <div>Visual Inspection<br/><b>V0</b></div> <div>Sipping</div> </div> </div> | |
