# ARCHITETURE OPTIMIZATION AT IPEN ANIMAL FACILITY IN ORDER TO IMPROVE THE WELFARE AND THE QUALITY OF THE ANIMALS EMPLOYED AT RADIOPHARMACEUTICAL TESTS

## **2. CURRENT STATUS OF THE ANIMAL HOUSE FACILITIES AT IPEN/CNEN - SP**

### **3. ADAPTATION PROJECT AND REFURBISHMENT OF THE ANIMAL HOUSE FACILITIES OF THE IPEN-CNEN/SP**

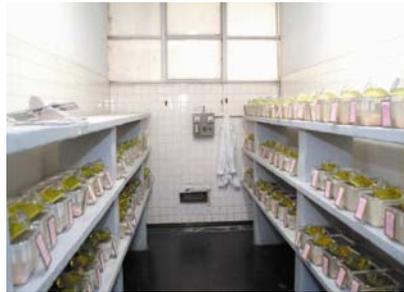
Nowadays, the IPEN's Animal House Facilities present revetments worn down by use and also with unsuitable project solutions taking into account the norms that should be adopted to the good operation of the facility. In the Rooms of Animal Breeding, the walls are covered with tiles, which impede the correct hygienic practice due to the dust accumulation at the tile junctions. The cages are arranged in shelves done in concrete, built in three levels at the

longitudinal axis of the room, as can be observed in the figure 1. That solution is not acceptable considering the new concepts of animal house facilities, due to the fact of the lining not to be suitable, because it propitiates the accumulation of dirt, also impeding the sanitation of the rooms. With concrete shelves, it is impossible to solve the problem of the air circulation among cages, since, this kind of shelves, do not allow the appropriate change of the air inside the cage. This poor air circulation leads to lung infections for the animals, as a consequence of the high level of ammonia. Additionally, this shelf type limits the space inside the room, avoiding the increase in the number of animals [2]. Besides, with this system its possible the presence of termites, as can be observed in the figure 2, that makes unfeasible the maintenance of an efficient sanitary pattern.

**Figure 1: Shelves in concrete and walls lined with tiles.**

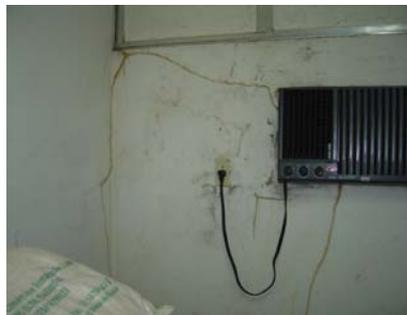
**Figure 2: Masonry with termite.**

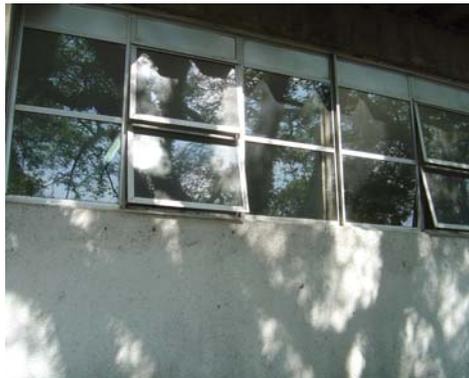
The windows have common glasses, what means the possibility of violation, as presented in the figure 3. The wood doors are quite deteriorated due to the termites, with cracks, disabling their perfect operation and liberating particles that contaminate the area and impede the correct sanitation, as observed in figure 4. The viewfinders of the doors are not also suitable, because they have reentrance that accumulates dust.

**Figure 3: Windows with common glasses, without isolation from the outdoor environment.**

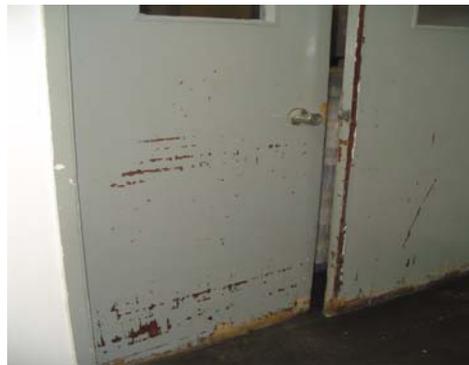
**Figure 4: Deteriorated doors.**

The wood doors were replaced by coated doors (Formica) built with double glass viewfinders, faced with the door surface figure 14. There was a great concern related to the used materials and the way they were applied, to avoid openings or saliencies. It was opened a space in the masonry and a door type counter were installed, linking the Septic Circulation to the Washing Area.

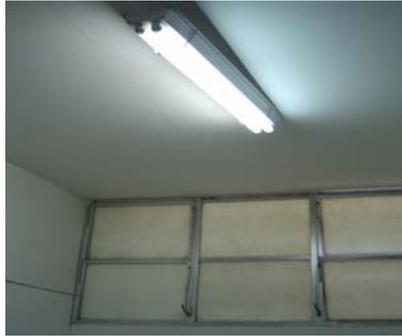
The illumination of the animal rooms is not effective, because the lamps are exposed, without any protection. This propitiates the dust accumulation, impeding the correct cleaning and acting like another polluting factor of the area, as shown in the figure 5 [2].

**Figure 5: Exposed lamps without any protection.**

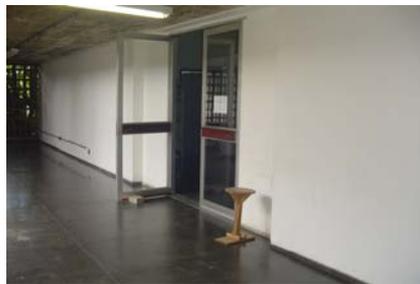
The main access to the facility is by a single door, linked directly to the exterior of the unit, exposing animals, people and activities to the outside environmental conditions and contaminations, allowing the entrance of insects and dust, impairing the sanitary colonies protocols, as shown in figure 6.

**Figure 6: Main entrance of the Animal House Facility.**

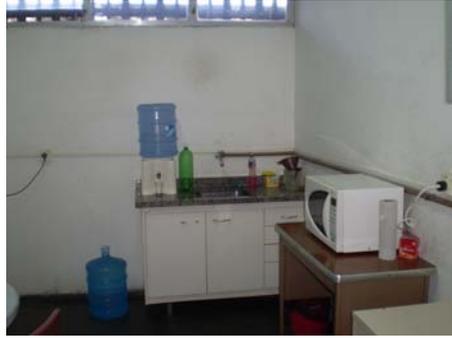
Additional problems were identified in the facility, such as the first room immediately after the main entrance that is used by the employees and the contiguous room is a pantry, observed in the figure 7, installed in a completely unsuitable place, according to the Biological Safety Norms.

**Figure 7: Pantry located inside the Animal House Facility.**

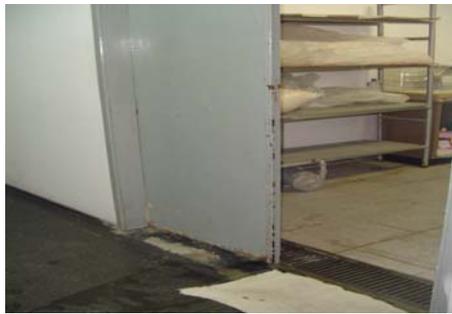
The Material's Washing Room is the area where the sanitation activities and sterilization of the materials used in the maintenance of the colonies of animals are concentrated. In the entrance of the room, there is a channel with iron grill and the width corresponds to the space of the door, what caused several incompatible situations, as blockage, ebb of water, entrance of insects, besides representing a point of constant contamination in the room, as observed in the figure 8.

**Figure 8: Channel with grill in the floor.**

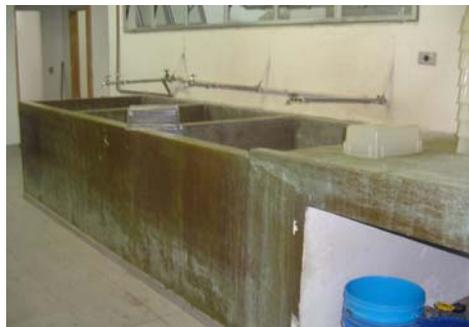
The existent tanks in the Material's Washing Room, observed in the figure 9, were built in concrete. Now, they present countless cracks that impede the perfect disinfection, committing the quality of the materials sanitation done at the room.

**Figure 9: Existent tanks in the Materials Washing Room.**

The refurbishment of the Animal House Facilities of IPEN doesn't become exhausted with those improvements. Actually, some materials are not yet satisfactorily adapted. For instance, in the case of the existent tanks in the Washing Room, there was a significant improvement, but the ideal material for their covering would be the stainless steel. However, due its high cost and to make possible the largest number of items to be executed in this stage of the refurbishment, the ceramic covering was adopted. It assists to the needs concerning the resistance, but it is not satisfactory due the existence of tile junctions. Another example is the floor in granulite. This is resistant, nevertheless it presents porosity. The application of an acrylic resin is essential to minimize the problems. The monolithic floor would be much better, because the total absence of junctions. Besides this, it is resistant to chemical products and its cleaning and disinfection is easier.

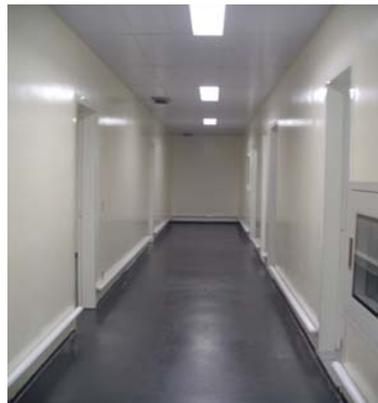
The corners formed by the walls with the floor and roof and between two walls, were rounded to facilitate the cleaning and the disinfection. All of the masonries were covered and painted later with epoxy resin, in order to offer great resistance for the disinfection routines.

**Figure 10: Aseptic corridor.**

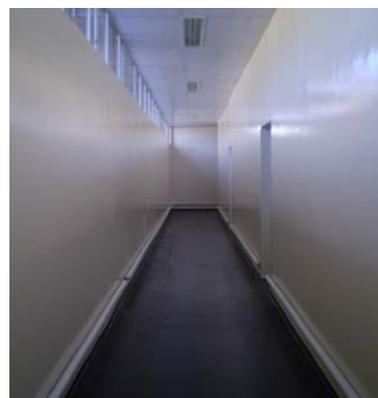
**Figure 11: Septic corridor.**

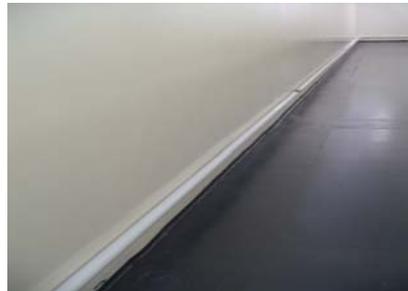
In the aseptic and septic circulation, galvanized tubes with electrostatic painting were installed to protect the inferior part of the masonries figure 12, avoiding damages caused by trails and others equipments. In the inferior part of the double door, a protection was installed to avoid the entrance of insects and dust figure 13.

**Figure 12: Galvanized tubes to protect the masonries.**

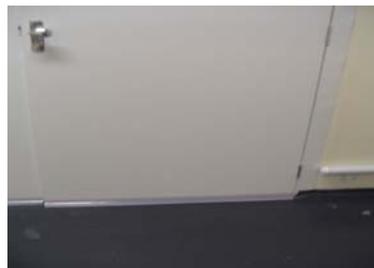
**Figure 13: Protection in the door to avoid the entrance of insects and dust.**

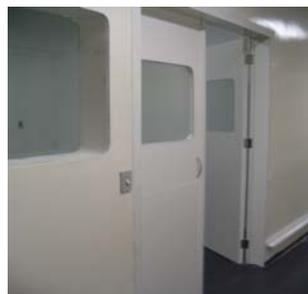
**Figure 14: Doors with viewfinders.**
