Essays on Nuclear Energy & Radioactive Waste Management

Opening the Goiânia Accident Unburied Waste Packages³

Abstract: The year 2017 marks 30 years since the radiological accident in Goiânia, Brazil, which resulted from the leakage of Cs-137 from a teletherapy equipment. The contaminated material collected during the response to the accident was disposed of in Abadia de Goiás, about 20 km from Goiânia. However, in the initial 15-day period before the authorities were notified, contaminated paper bales and scrap metal were sold and transported to material recycling facilities in the State of São Paulo, one thousand kilometers away. These materials were later collected in steel boxes and drums, and stored in the intermediate waste storage facility of the Nuclear and Energy Research Institute - IPEN, in São Paulo. The objective of this paper is to describe the work performed to check the present condition of the paper bales waste boxes, reassess the reported Cs-137 activities, and evaluate possible treatment methods that can be applied to reduce the volume of waste. Prospective waste treatment methods are discussed.

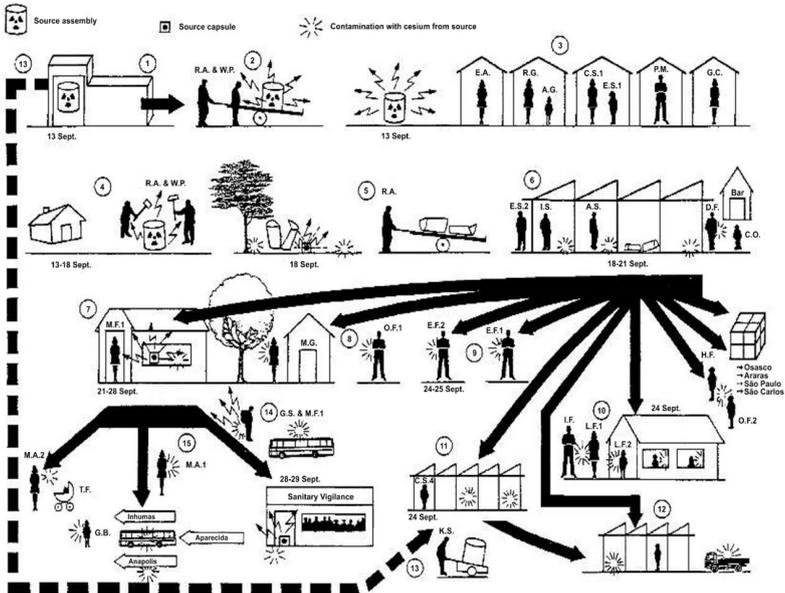
Key: (1) the derelict clinic of the IGR; (2) removal of the rotating source assembly from an abandoned teletherapy machine by R.A. and W.P.; (3) source assembly placed in R.A.'s yard near houses rented out by R.A.'s mother E.A.; (4) R.A. and W.P. break up source wheel and puncture source capsule; (5) R.A. sells pieces of the source assembly to Junkyard I; (6) Junkyard I: the cesium chloride is fragmented and dispersed by I.S. and A.S. via public places; (7) D.F.'s house: contamination is further dispersed; (8) visitors and neighbors, e.g. O.F.1 are contaminated; (9) E.F.1 and E.F.2 contaminated; (10) I.F.'s house; other arrows indicate dispersion via visitors and contaminated scrap paper sent to other towns; (11) contamination is spread to Junkyard II; (12) contamination is spread to Junkyard III; (13) K.S. returns to the IGR clinic to remove the rest of the teletherapy machine to Junkyard II; (14) M.F.1 and G.S. take the source remnants by city bus to the Sanitary Vigilance; (15) contamination transferred to other towns by M.A.1.

Figure 1 - Diagram of the dispersion of Cs-137 in the Goiânia accident [1].

During this period, the cesium chloride from the sealed source was being dispersed between people and their homes, contaminating buildings and every object inside them, in their yards and among the domestic animals, and the materials they collected for recycling and stored in the scrapyards. A diagram based on a drawing made shortly after the discovery of the accident, trying to explain what happened, is presented in Figure 1 [1].

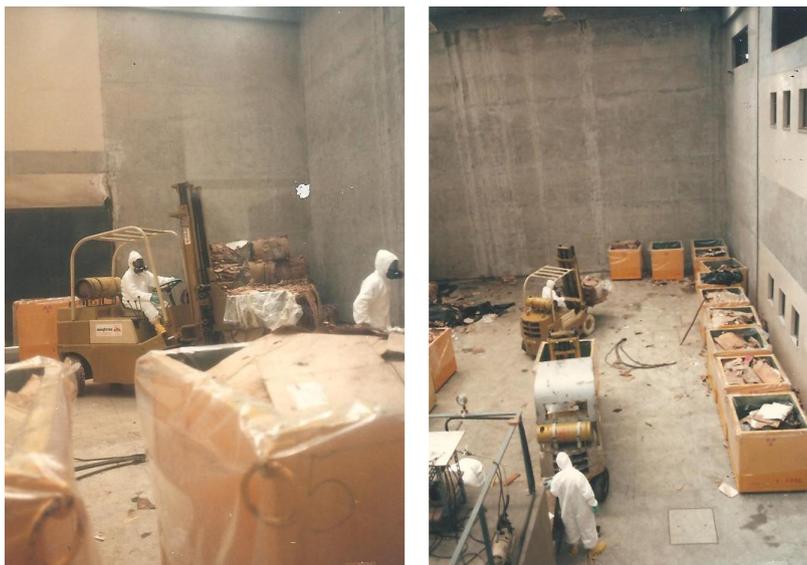
Figure 2 - Contaminated paper bales collected and stored in the waste boxes in August 1988.

In the same way, recycling materials contaminated locations in four cities in the State of São Paulo. Scrap metal and paper bales were sold by the scavengers to recycling factories in the cities of São Paulo, Osasco, Araras and São Carlos. Approximately 8,000 kg of metal pieces, collected in the operations of decontamination of those factories (Figure 2), resulted in forty-three 200-liter drums, and 39,000 kg of discarded paper resulted in fifty 1.6 m³ steel boxes. The option of sending these waste packages back to Goiânia was discarded because of the anxiety and disturbance throughout the country after the accident. These drums and boxes containing the recovered wastes are currently stored in the

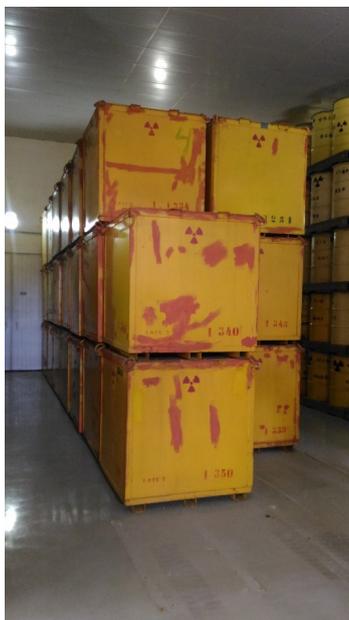
Figure 3 - Boxes with waste from the Goiânia accident today. The stains are scratches on the painting and corrosion points that were fixed.

intermediate radioactive waste storage facility of the Nuclear and Energy Research Institute, in the city of São Paulo. Figure 3 shows part of the packages in the storage room.

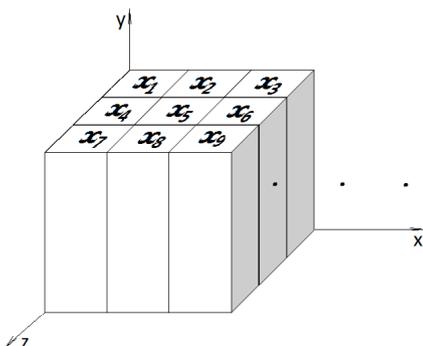
Figure 4 - Modelling of the MicroShield geometry (the dots are measurement points).

The results of the measurements were used as input to calculate the estimated activities. To take into account the large inhomogeneity of the radioactive content, the measurement of each side was attributed to 1/9 fraction of the waste mass, as the modelling considers a 3x3 matrix of homogeneous regions, and used the MicroShield® to refine the initial estimates. The procedure was repeated until an acceptable distribution of activity was obtained, which correlates with the measurements (Figure 4).

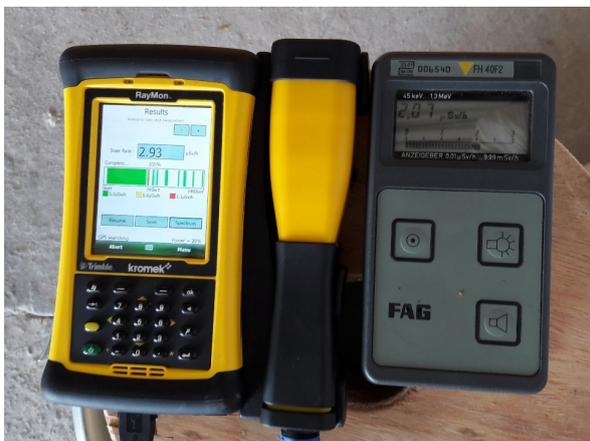
Figure 5 - Kromek RayMon10® & Eberline FH 40F2 radiation monitors.

The dosimeters used for the measurements were the following (Figure 5):

- Kromek RayMon10^{®5} radiation monitor;
- Eberline FH 40F2 radiation monitor.
