## Original Article

# Microstructure and fatigue properties of extruded aluminum alloys 7046 and 7108 for automotive applications

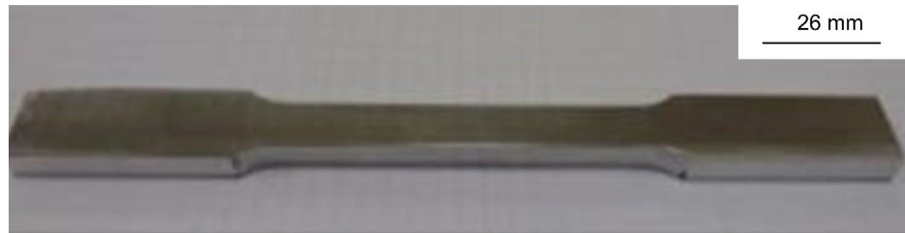
Fig. 2 – Specimen for tensile and fatigue tests machined from extruded profiles of AA7108 and AA7046.

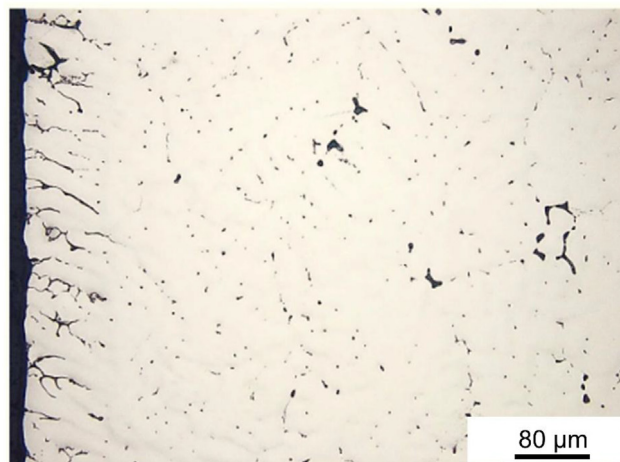
Fig. 3 – Periphery micrograph of the cross section of the AA7108 billet in the as-casted condition. (A) Chemically etched and anodized micrograph and (B) without etching.

conditions, respectively. Fig. 3(A) illustrates the geometry and size of the grains, characteristic of the uniform heat extraction rate at the periphery of the billet. The interdendritic microsegregation inside the grains is evidenced by the difference in color from the center of the grains to the ends, with a characteristic geometry of dendritic growth. Due to the low speed of solidification practiced, the solutes were pushed to the

solidification front, as visible in Fig. 3(B). Consequently, the precipitated phases are almost completely at the grain boundaries of the  $\alpha$ -Al phase.

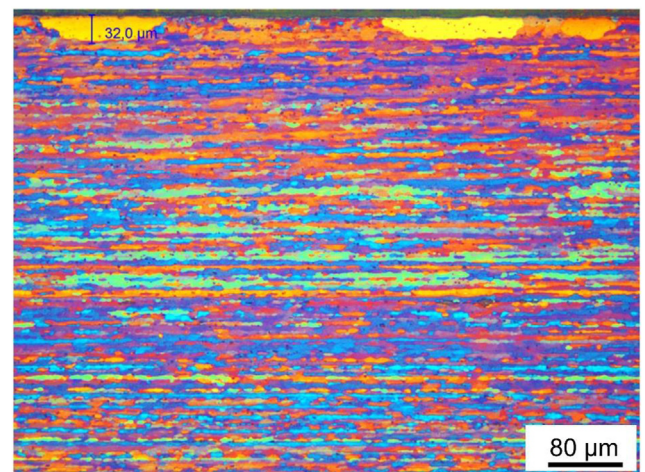
**Fig. 9 – Micrograph observed with polarized light of a sample of the longitudinal section of the extruded profile of the solubilized and aged AA7108.**

After homogenization, the billet was reheated to 480 °C to enable its hot extrusion. In addition to a pronounced increase in billet formability, the precipitates were redissolved, and the alloying elements were again solubilized in the Al matrix. Then, the solubilized profile was subjected to the aging heat treatment. Figs. 9 and 10 present the micrographs of the longitudinal section of the extruded bars of the AA7108 in its solubilized and artificially aged condition. Fig. 9 illustrates the microstructure of elongated grains along the length of the extruded profile is presented. As noted in a previous work [18], the material is highly textured, with the grains severely elongated in the (111) and (200) orientation of the planes along the direction of extrusion. Fig. 9 also exhibits subgrains within

the elongated initial grains arranged in rows parallel to the direction of extrusion. This microstructure also displays the presence of recrystallized grains on the upper surface with a maximum depth of 35  $\mu\text{m}$ .

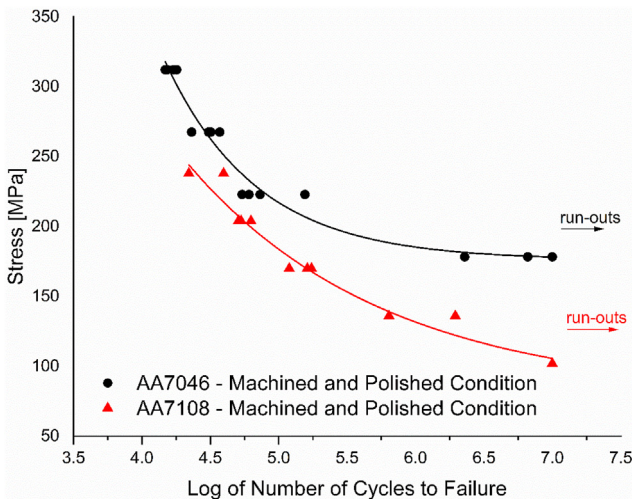
**Fig. 15 – S–N curves from fatigue tests performed on specimens in the machined and polished condition for AA7046 and AA7108. The arrows indicate the tests interrupted after  $10^7$  cycles without fracturing.**

Fig. 15 presents the S–N curves obtained from fatigue tests on machined-and-polished 7108 and AA7046 samples. The red curve was obtained from fatigue tests on AA7046 samples and the black curve on AA7108. As stated earlier, the dots on the graph accompanied by an arrow indicate test interruption with  $10^7$  cycles without fracturing. These curves evidence that the AA7046 has better fatigue properties than the AA7108. This is due to the greater amount of alloying elements responsible for precipitation hardening in the AA7046.
