# A CORROSION MONITORING PROGRAMME FOR RESEARCH REACTOR SPENT FUEL BASINS

## Abstract

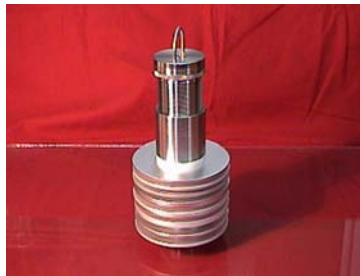
Figure 1. A typical corrosion test rack with coupons.

A variety of test racks with test coupons of varying shapes and sizes have been used in CMPs. The models used in CRP-II and the RLA are recommended as these racks evolved from other designs. Figure 1 shows a typical corrosion test rack with the coupons and separators. The coupons are made of materials that are identical to or similar to materials used in the spent fuel storage basin. The insulating separator physically isolates one coupon from another and from other metallic parts of the test rack. It should therefore be an insulating, non-porous and resistant to radiation, like dense alpha-alumina. The coupons are usually arranged horizontally even though fuel plates within fuel assemblies are vertical. Experience gained in the CRPs revealed that horizontal coupons are more susceptible to corrosion compared with vertical coupons. Consequently, it is recommended that CMPs use horizontal coupons as the conditions are much more severe and therefore an early warning mode in terms of corrosion of vertical fuel plates and assemblies.

The Al alloys studied in the projects mentioned earlier were AA 1050, AA 1100, AA 6061 and SZAV-1. The coupons were 3 mm thick and 10 cm in diameter with a central hole to enable stacking in an all-stainless steel test rack with a stem and a nut with a hook to suspend the assembled rack in the spent fuel basin. The test rack assemblies also contained coupons to evaluate crevice and bimetallic corrosion.

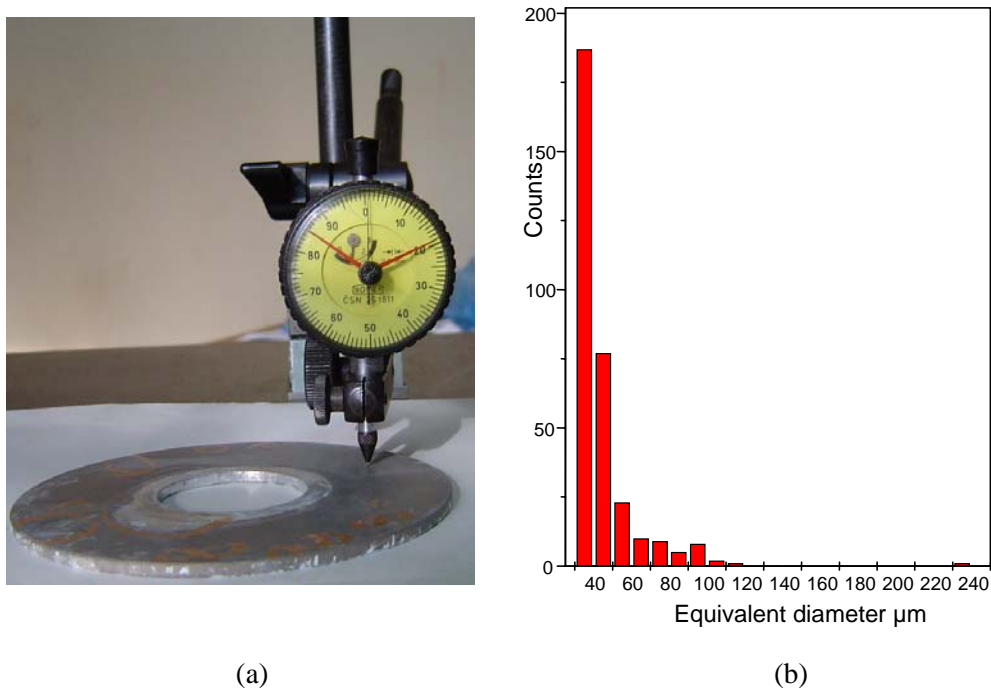
Figure 9. (a) Device used to measure pit depths, with 10 μm resolution. (b) A histogram of number of pits versus pit diameter on a coupon surface.

- (f) Measuring pH (with pH paper) on the contact surfaces of crevice and bimetallic coupons.
- (g) Decontaminating the coupon while still wet.
- (h) Examining coupon surfaces to record other corrosion features. (Figures 8 (b-d))
- (i) Evaluation of the extent of pitting corrosion with the aid of an optical microscope or an image analysis system.
- (j) Determination of pit depths from image analysis data or with a calibrated focusing technique ( Figure 9 a) or using standard metallographic techniques (repeated polishing followed by optical microscopy).

- (k) Recording the deepest pit and preparing histograms of pit depths and number of pits in different pit depth ranges. ( Figure 9 b)
- (l) Evaluate the extent of pitting on the contact surfaces of the crevice and bimetallic couples.
