## CORROSION OF RESEARCH REACTOR AL-CLAD SPENT FUEL IN WATER

### SUMMARY

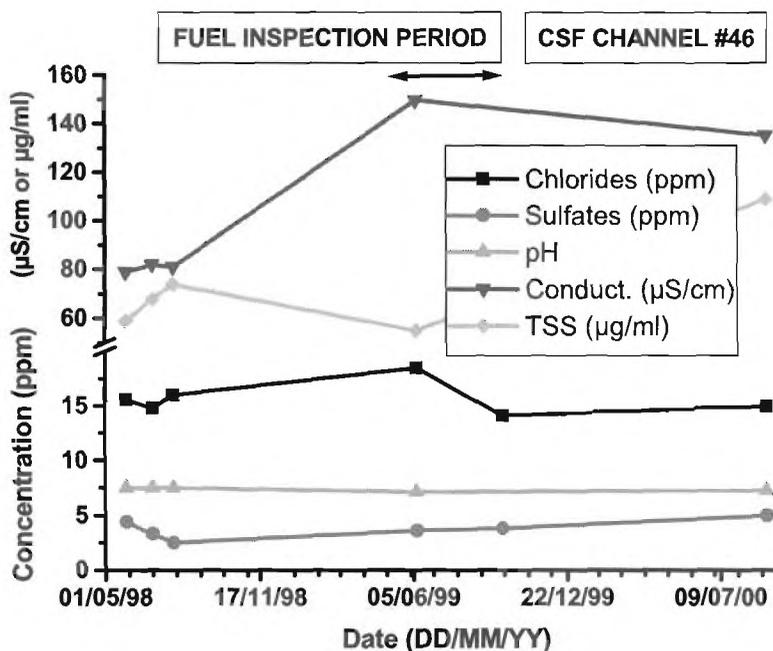
Fig. 5: Variation in water parameters in CSF #46

In mid-1998, six additional racks containing crevice and galvanic couple coupons were immersed at EFC, the RA3 decay pool, the RA6 reactor pool, and the RA6 decay pool. These pools provided a wide range of water chemistry conditions. Figs. 5 and 6 show variations in chemical parameters of the EFC and RA3 decay pool waters with time. The conductivity ranged from 227  $\mu\text{S}/\text{cm}$  in the EFC down to 1.8  $\mu\text{S}/\text{cm}$  in the RA6 reactor pool. The chloride ion content ranged from 16 ppm in the EFC to less than 0.5 ppm in the reactor pool. The racks immersed in the different basins contained coupons provided by the IAEA and aluminium alloy coupons used in the manufacture of Argentine fuel. Racks were immersed in the basins in mid-1998. Some were removed and examined in August 1999 and others in February, July, and September 2000. Severe pitting and crevice corrosion was noted on most of the aluminium coupons in the EFC, where the water was most aggressive. Much of the pitting on the external surfaces was caused by deposition of what was thought to be iron oxide particles from the corrosion of the carbon steel cover plates. Fig. 7 shows a coupon surface with crevice corrosion products and Figs. 8-12 the surfaces and cross-sections of different pitted Al coupons
