GAMMA RAYS IRRADIATION PROCESS ON A RESTORED PAINTING FROM THE XVIITH CENTURY

***Marcia M. Rizzo**^{1,2}, **Luci D.B. Machado**³, **Paulo R. Rela**³, **Yasko Kodama**³

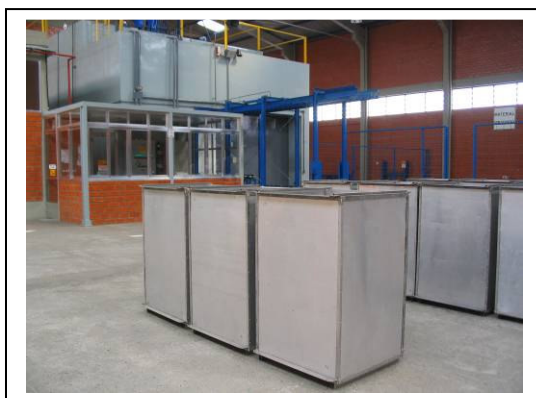
Figure 4. View of the outside of the IPEN irradiator.

All the irradiation process was repeated with the new dose selected. The painting was irradiated at the IPEN irradiator (Fig.4).
