SPENT FUEL ASSESSMENT, ISOLATION OF LEAKERS, STUDIES WITH CORROSION COUPONS AND PREPARATIONS FOR SHIPMENT ABROAD

Lalgudi V.Ramanathan

Instituto de Pesquisas Energeticas e Nucleares Energy and Nuclear Research Institute Travessa R-400, Cidade Universitaria 05422-970 São Paulo. Brazil

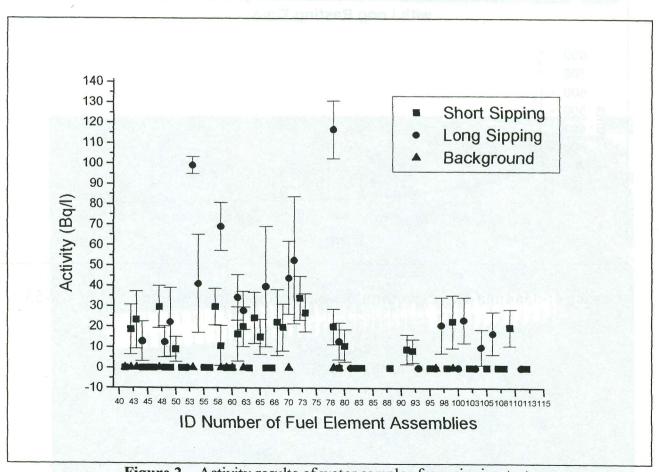
fuel assemblies showed the ¹³⁷Cs photopeak; (b) fuel assemblies for which two water samples were takeni showed an ncrease in activity with time. This indicated that the fuel assembly was leaking. It is possible to determine the leak rate of ¹³⁷Cs for the FA. For example, for the fuel assembly IEA-53 this rate was ~0.2 Bq/l.min or ~14 Bq/min. Figure 2 shows the specific activity for each fuel assembly in the sipping test. Some fuel assemblies showed leaks, and most of the FAs had specific activities lower than 30 Bq/l (water residence time of 4 hours). Figures 3 and 4 show the gamma spectra for a non-leaking and a leaking FA respectively.

Figure 2 – Activity results of water samples from sipping tests
