## Coatings for Safe Long Term Wet Storage of Spent Al-clad Research Reactor Fuels

Key Words: Hydrotalcite coating, aluminium cladding, pitting corrosion, spent research reactor fuel.

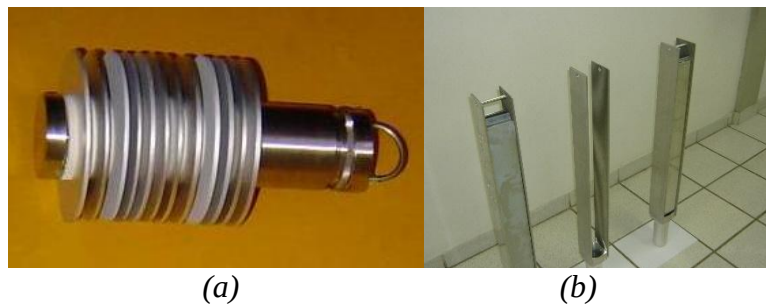
FIG. 1. Photographs of: (a) coupons stacked in a rack; (b) plates assembled to form dummy fuel elements.

The field test procedure consisted of: (a) preparing uncoated and coated coupons and plates; (b) stacking of the coupons in racks (Fig. 1 a); (c) assembling the plates to form a full size dummy fuel element (Fig. 1 b); (d) immersion of the racks and the dummy fuel elements in

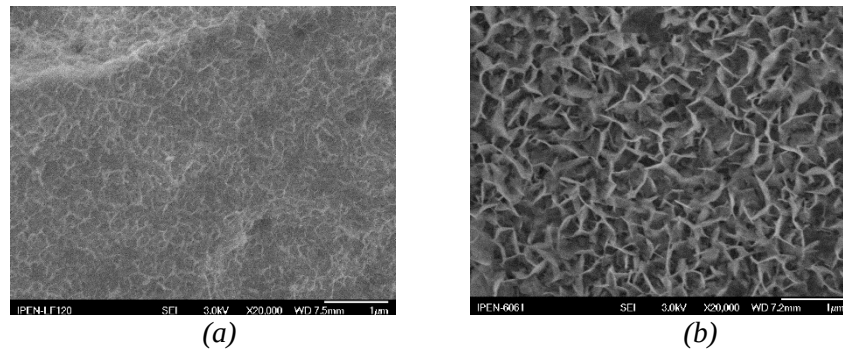
The morphology of LT-HTC and HT-HTC, formed from solutions 3 and 4 are shown in Fig. 2. The surfaces revealed intersecting blade like HTC crystallites that formed a layer across the surface. The LT-HTC coating is thinner and the crystallite, quite small. In order to obtain HTC with features similar to that of HT-HTC from a bath at room temperature, solution 3 was prepared with additions of  $H_2O_2$  and/or  $K_2S_2O_8$ . The coatings obtained from these baths are shown in Fig.3 and these reveal well-formed intersecting crystallites. Formation of this morphology is essential to incorporate cerium in the coating. Typical HT-HTC coating thickness after 10 minutes of immersion was  $\sim 2 \mu m$ . A layer of amorphous or nanocrystalline lithium aluminate forms below the outer layer and this was confirmed from the broadened x-ray diffraction peaks. [8]

FIG. 2. Scanning electron micrographs of: (a) LT-HTC (b) HT-HTC.

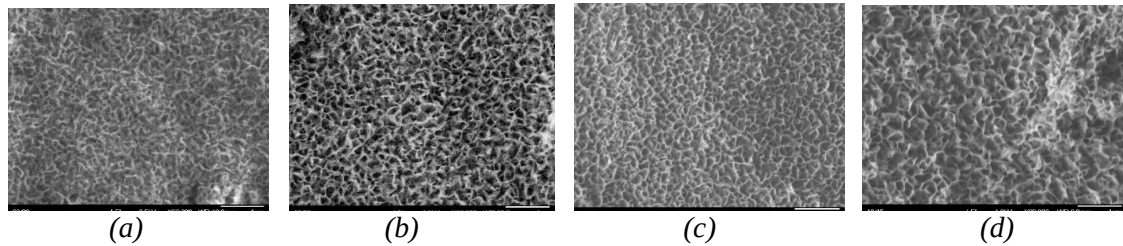
FIG. 3. Scanning electron micrographs of HTC coatings formed from solution 3 at room temperature: (a) without additions; (b) with  $H_2O_2$ ; (c) with  $K_2S_2O_8$ ; (d) with  $H_2O_2$  and  $K_2S_2O_8$ .

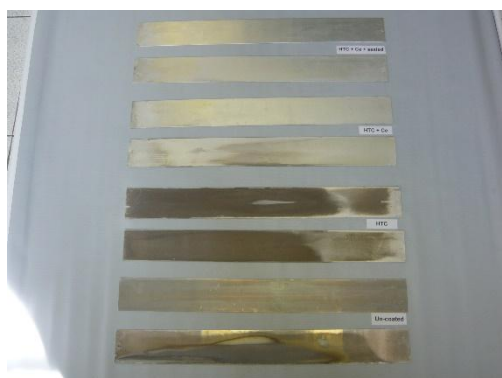
FIG. 4. Photograph of surfaces of full-size uncoated and HTC coated plates. The plates above the identification mark were exposed for 8 months and the plates below, for 14 months.

Fig. 4 shows a photograph of the uncoated and coated plates that were exposed to the IEA-R1 reactor spent fuel section. The plates stained to different extent, depending on the duration of exposure and the nature of surface treatment. The HTC coated plates were stained very dark compared with the uncoated plates. These plates however did not reveal pits. All these plates were examined visually and with an optical microscope and the main surface features are summarized in Table VII.

The uncoated plate exposed for 14 months was more stained than that exposed for 8 months. The HTC coated plates exposed for 8 and 14 months were heavily stained. The HTC + Ce coated plates did not reveal stains after 8 months but were slightly stained after 14 months. The plates that were HTC coated, cerium treated and sealed did not reveal any stains or pits after 8 and 14 months, indicating marked increase in the corrosion resistance imparted by the HTC coating followed by cerium incorporation and sealing.
