## MICROSTRUCTURAL ANALYSIS OF Ti-6Al-4V ALLOY AFTER PLASMA IMMERSION ION IMPLANTATION (PIII)

**Keywords:** Ti-Al-4V alloy, creep resistance, plasma immersion ion implantation

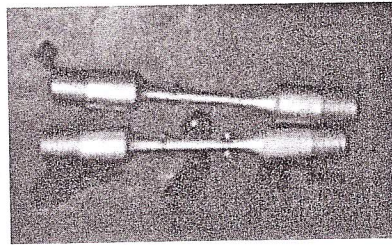
Fig. 1 – Creep specimens.

The material used in this work was obtained in Multialloy Eng. Mat. Ltda, forged and annealed at 190°C during 6 hours and cooled in air. The creep specimens of Ti-6Al-4V alloy are presented in Figure 1. Two samples were treated by PIII treatment (Figure 2) at Instituto Nacional de Pesquisas Espaciais (INPE). In this treatment the samples were put in a vacuum reactor with pressure of  $76 \times 10^{-3}$  Pa and implanted by nitrogen ions during 120 minutes. The frequency used was

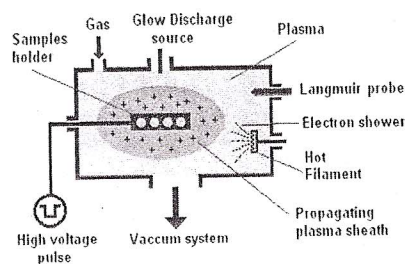
Fig. 2 – Schematic diagram for PIII apparatus.

400 Hz, pulse of 40  $\mu$ s and voltage varying between 7 and 10 kV. All the samples of Ti-6Al-4V alloy, untreated and treated by PIII, were submitted to creep tests at 600°C and 250 at 319 MPa under constant load mode at Instituto Tecnológico de Aeronáutica (ITA/CTA). Creep tests were realized using MAYES machines. Antares Software was used to collect the data on the elongation of the samples and the measuring of temperature in pre determined periods of time. It was used a transducer-type LVDT Schlumberger D 6.50 to obtain measures of elongation and it was used Cromel-Alumel thermocouple type AWG24 to control temperature. The creep tests were realized in accord to the standard ASTM E139 [8].

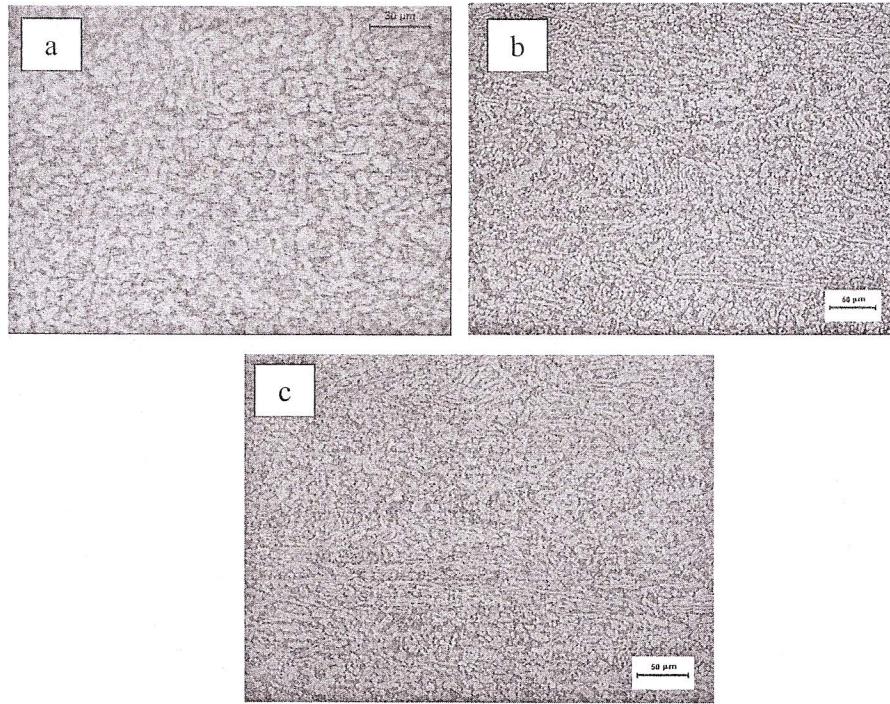
Fig. 3 - Micrograph analysis of Ti-6Al-4V alloy (a) untreated; (b) treated by PIII after creep test (600°C; 250 MPa) and (c) treated by PIII after creep test (600°C; 319 MPa)

Figure 3a shows the microstructure of the annealed Ti-6Al-4V alloy. It could be observed  $\alpha$  grains (CH) and dark regions that define the presence of  $\beta$  phase (BCC) along the grain boundaries of the alloy. Ti-6Al-4V PIII treated micrograph (Figure 3b) shows similar structure than untreated alloy with thin structure and small grains. Using XRD analysis was possible to observe the  $Ti_2N$  phase (Figure 4). The PIII treatment produces a thin layer of  $Ti_2N$  with 0.6 nm of thickness.

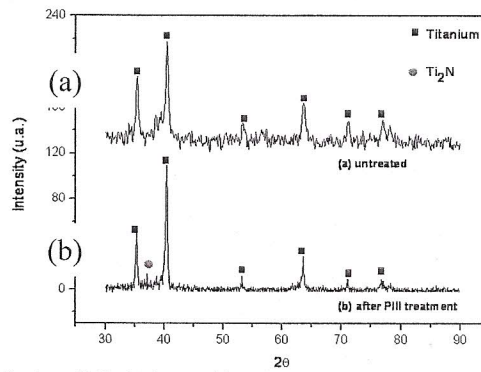
Fig. 4 - XRD analysis of Ti-6Al-4V alloy (a) untreated and (b) treated by PIII.

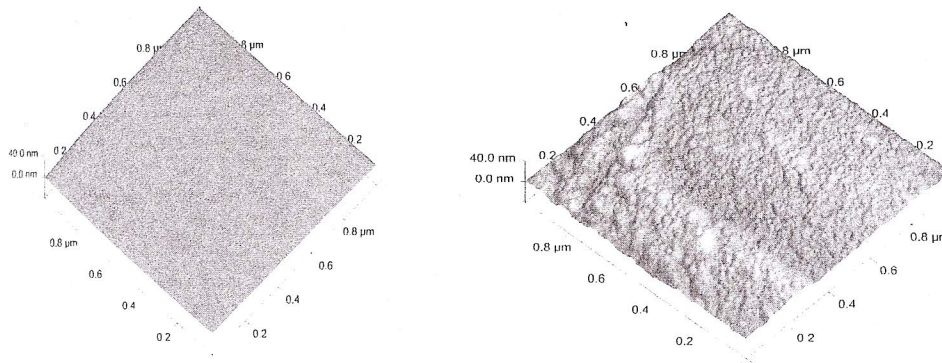
Fig. 5 - AFM analysis of Ti-6Al-4V alloy (a) untreated sample (b) treated sample.

Figure 5 shows AFM analysis. The roughness increasing in PIII treated alloy, probably due to the ions sputtering on the surface, this was verified in recent works in literature [9-10]. The sample treated by PIII presents average roughness (rms) of 1.94 nm, while the untreated sample the value is 0.09 nm.

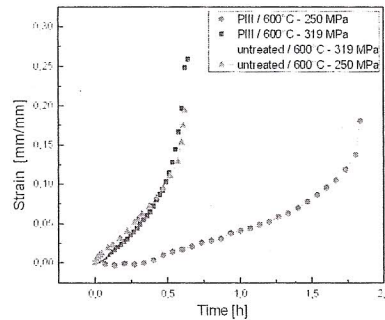
Fig. 6 - Creep curves of Ti-6Al-4V alloy obtained at 600 °C, 250 and 319 MPa.

Figure 6 presents the creep curves obtained by Ti-6Al-4V treated by PIII and untreated at 600°C and 250 MPa and 319 MPa. The Ti-6Al-4V alloy shows a normal curve of creep stages consisting of primary, secondary and tertiary well defined. There is a relatively short initial period of decreasing primary creep rate that is associated with hardening due to the accumulation of dislocations. However, most of the creep life is dominated by a constant creep rate that is thought to be associated with a stable dislocation configuration due to recovery and hardening process.

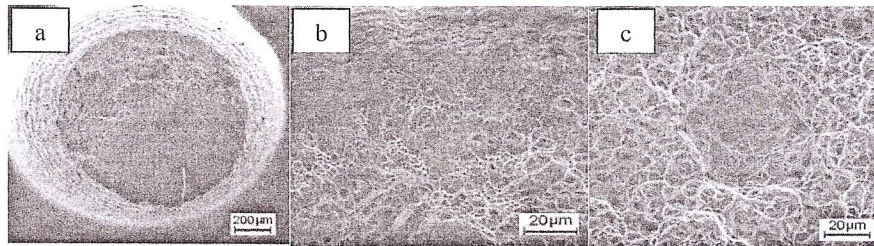
Fig. 7 - Fractograph analysis of Ti-6Al-4V alloy treated by PIII after creep test at 600°C and 250 MPa. (a) general view, (b) lateral view and (c) center view.

The Figures 7 and 8 show images obtained by SEM to fractograph evaluation of the alloy treated by PIII after creep test. It can be evidenced microcavities development and dimples.

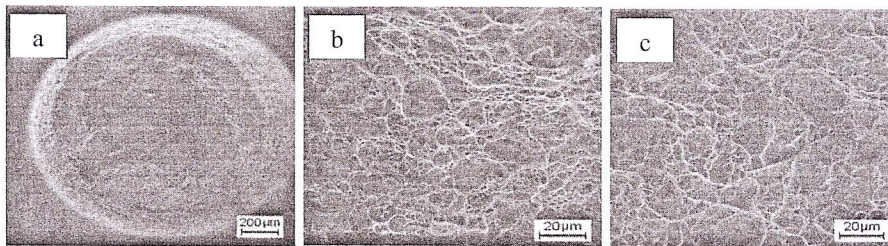
Fig. 8 - Fractograph analysis of Ti-6Al-4V alloy treated by PIII after creep test at 600°C and 319 MPa. (a) general view, (b) lateral view and (c) center view.
